Environmental Monitoring Report

April ~ September 2020

for Redevelopment and
Enhanced Oil Recovery (EOR)
Programme

MPRL E&P Pte Ltd.

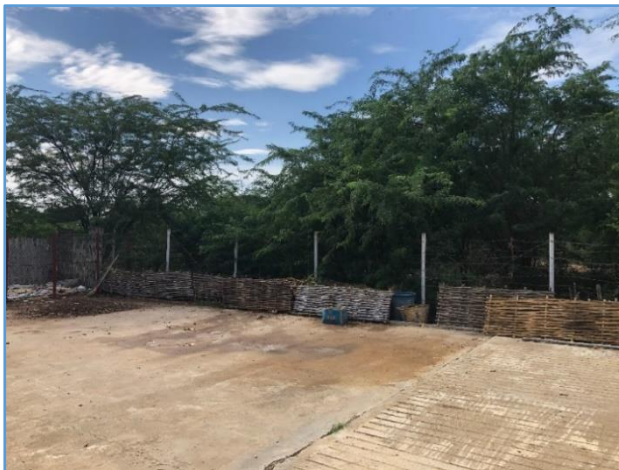
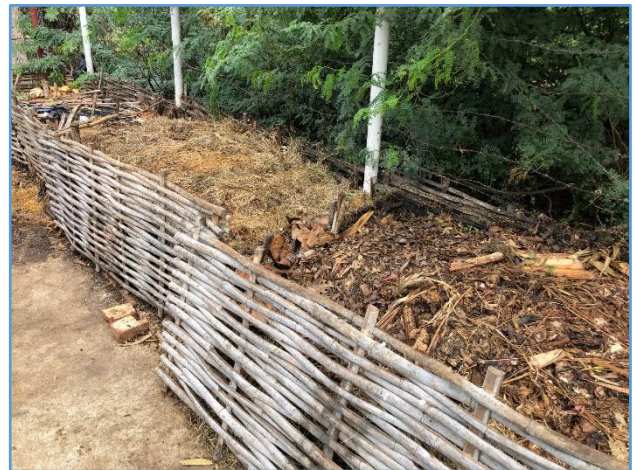
Figure 5: Composting Process

According to our within 6-month self-monitoring records, from April 2020 to September 2020, the composting process is produced about 520 Kg. This process is very fast in the summer but in the rainy season the composting bacteria not work best under neutral conditions.

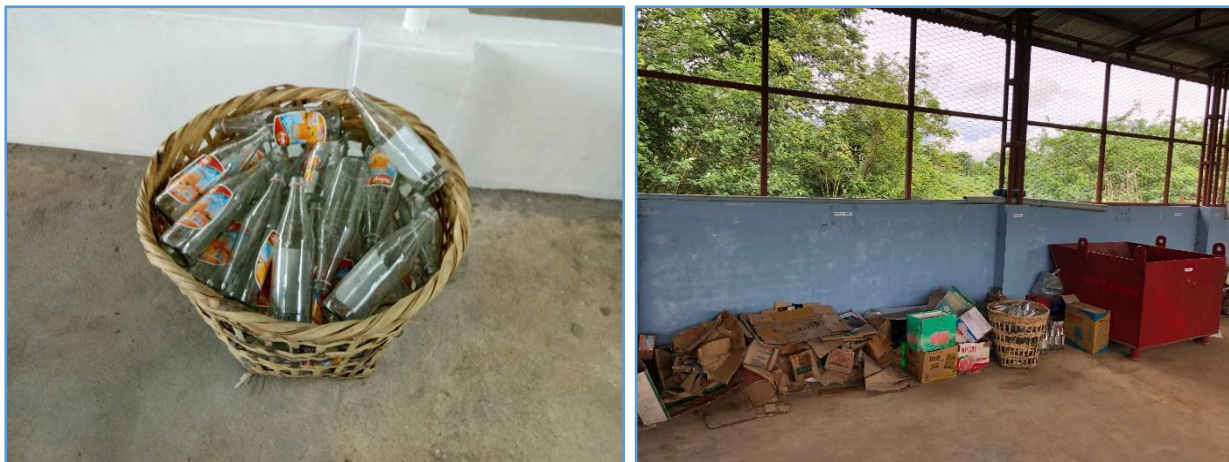
Figure 7: Recycle Waste in WMC

Recycling materials such as glass, paper and cardboard, plastics bottles, and metals, 2727 Kg are collected and sold out to the third party. Recycling materials are collected and separately from general waste.

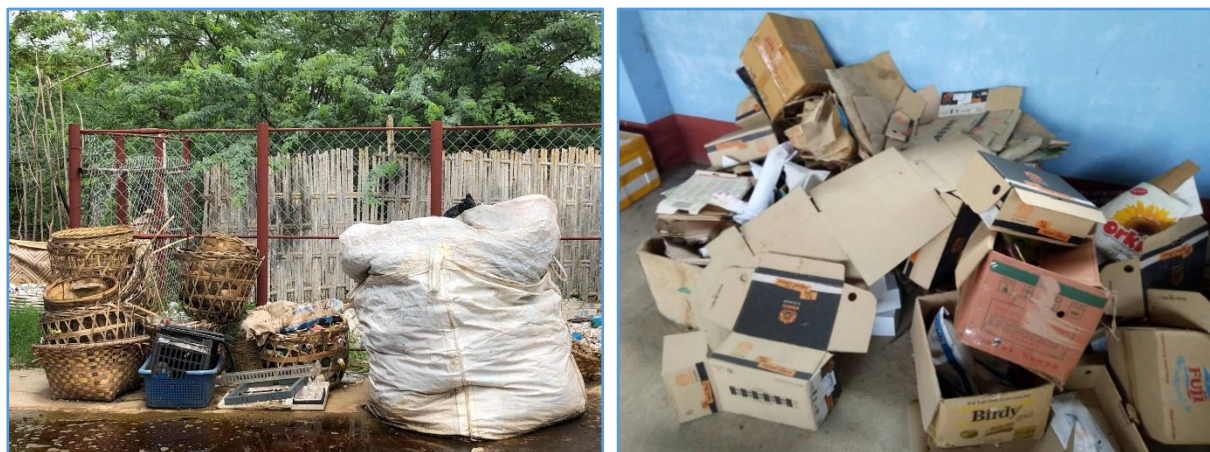
Figure 8: General Waste Storage in WMC

General waste 4000 Kg collection from all area in the Mann Field operations during one year and temporary storage at Waste Management Compound. Field team managed cleaning and disposing the general waste by using Jambo bags and dispensed to designated area.

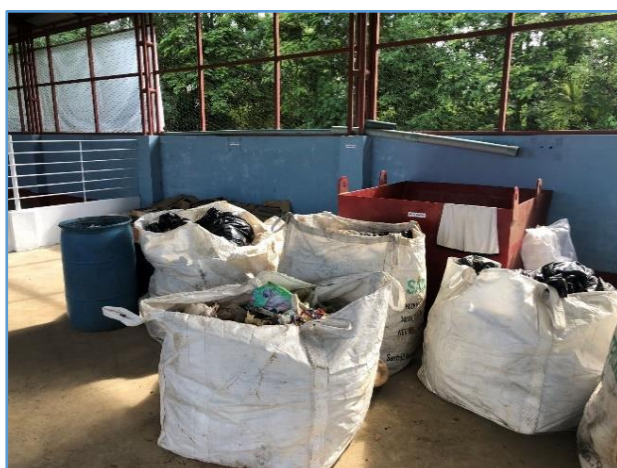
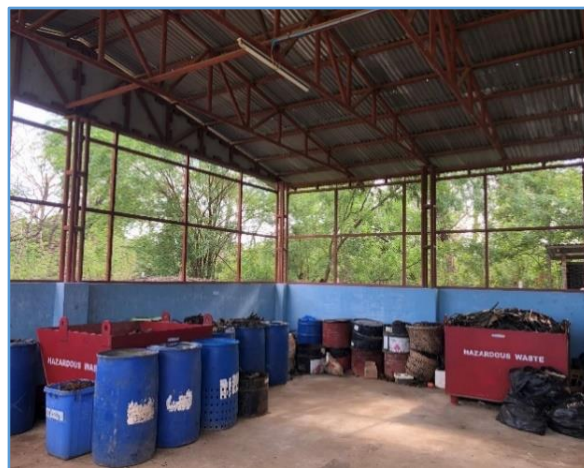
Figure 11: Hazardous Waste Storage in WMC

Hazardous waste, 602 Kg are collected from all work related area and properly storage at Waste Management Compound. Now preparing work order process with GOLDEN DOWA ECOSYSTEM for adequate disposal method.

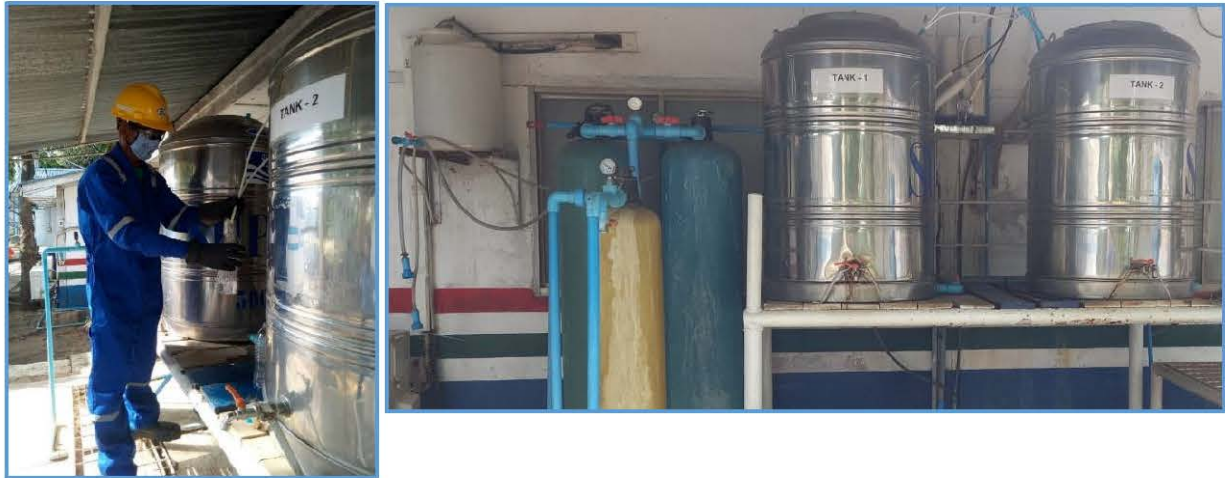
In the base camp, MPRL E&P installed a purified drinking water machine (RO System) for drinking and food preparation to cover enough consumption for all staff who are living in the base camp. The team is monitoring water quality quarterly and perform hygiene inspections and audits by the site doctor and HSE team as per the planned schedule.

Figure 27: Drinking Water Purify Machine for the Base Camp

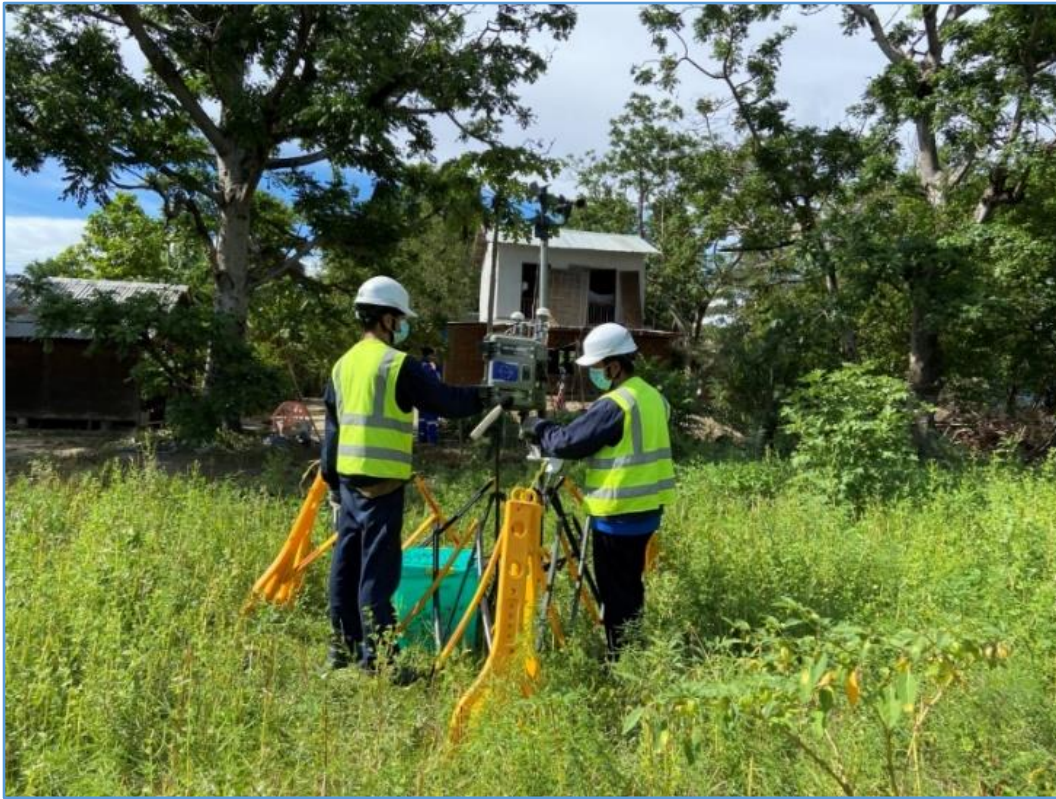
Figure 31: Station - Z1AQN (Air & Noise Monitoring)

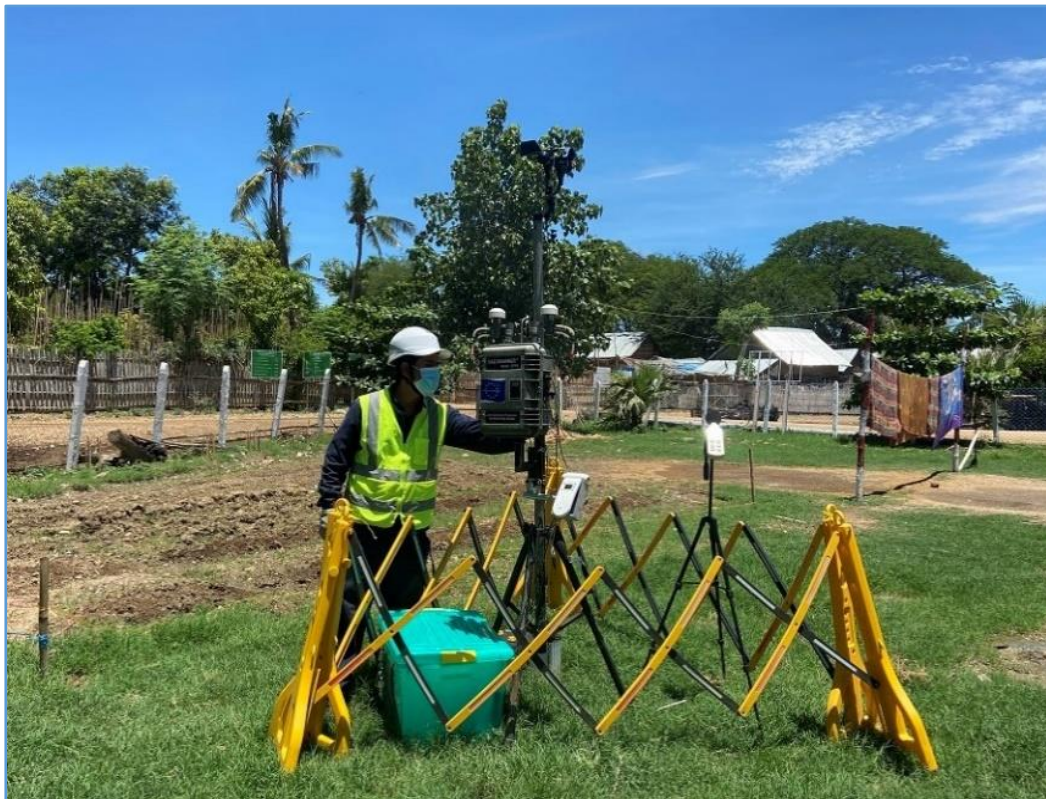
Figure 32: Station – Z2AQN (Air & Noise Monitoring)

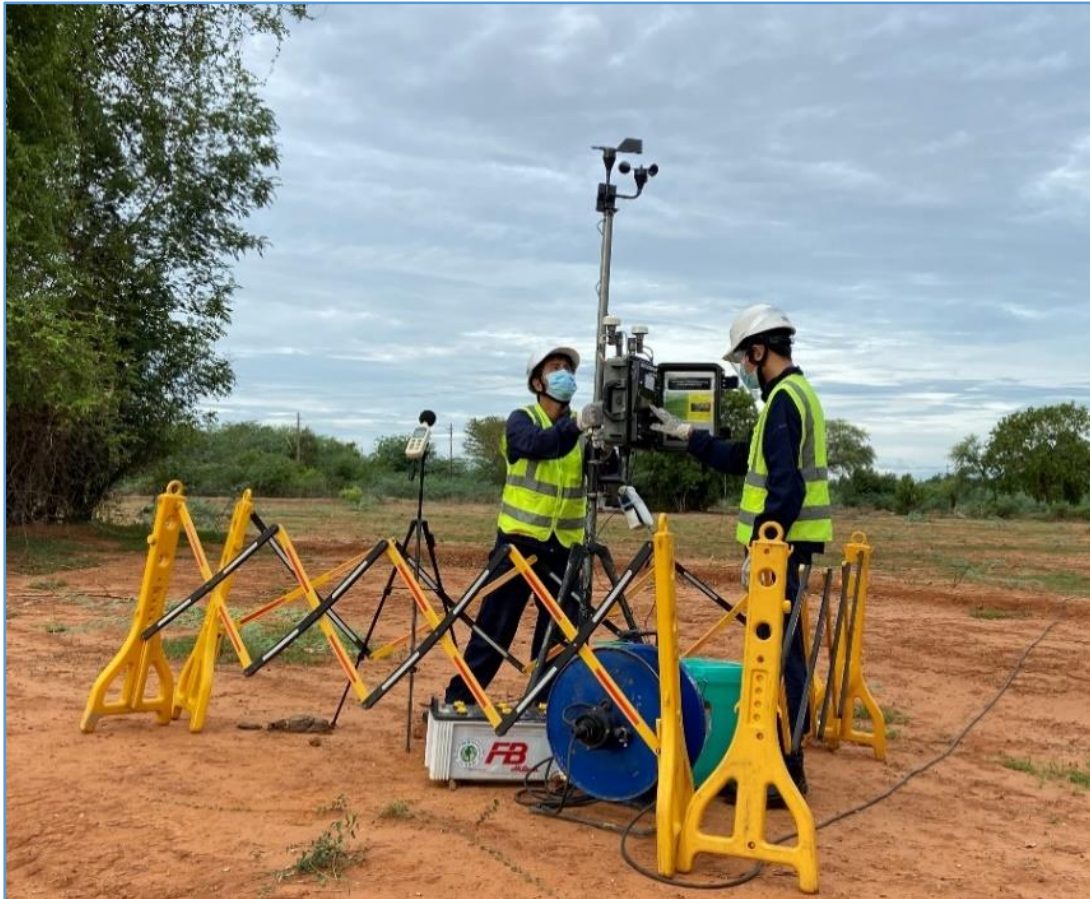
Figure 33: Station – Z3AQN (Air & Noise Monitoring)

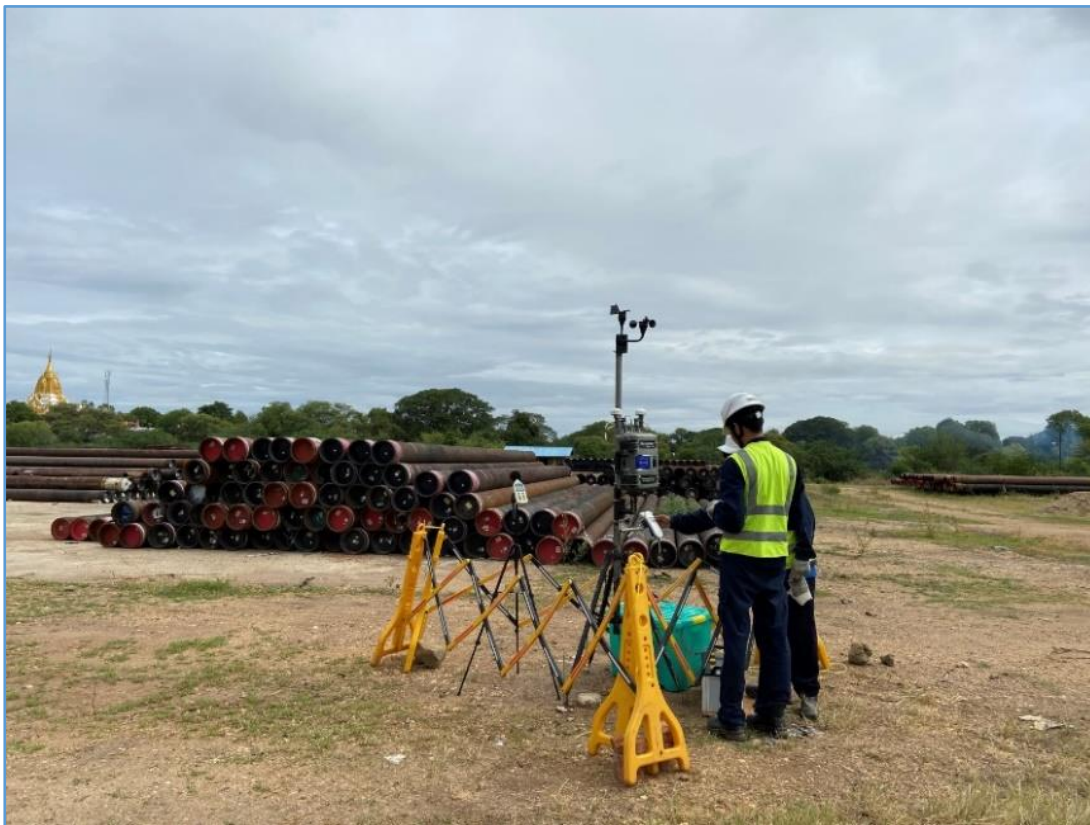
Figure 34: Station – Z4AQN (Air & Noise Monitoring)

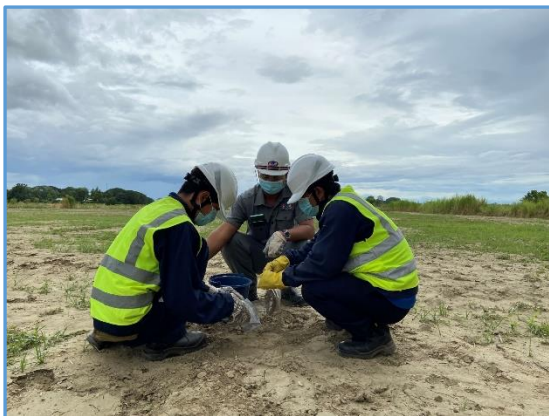
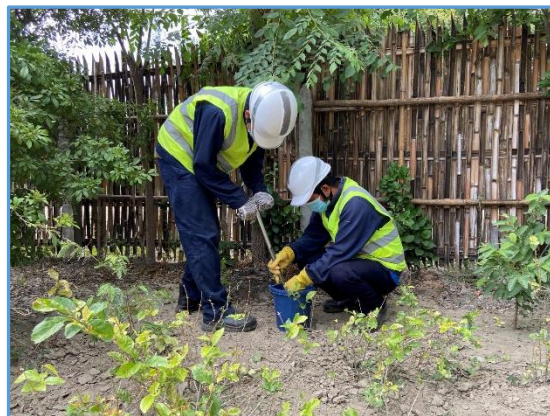
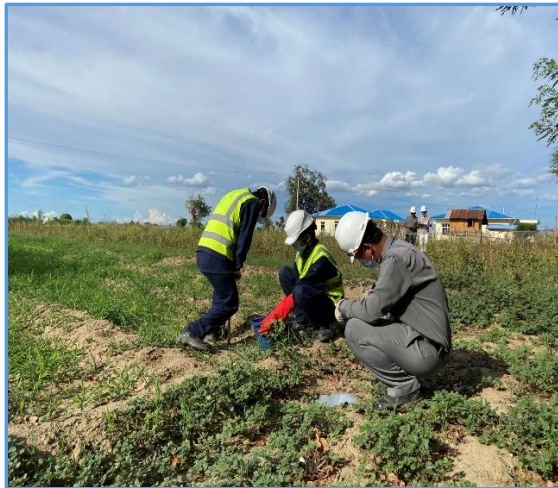
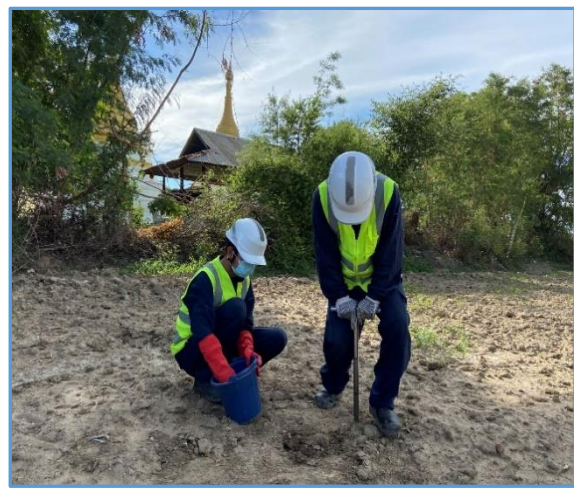
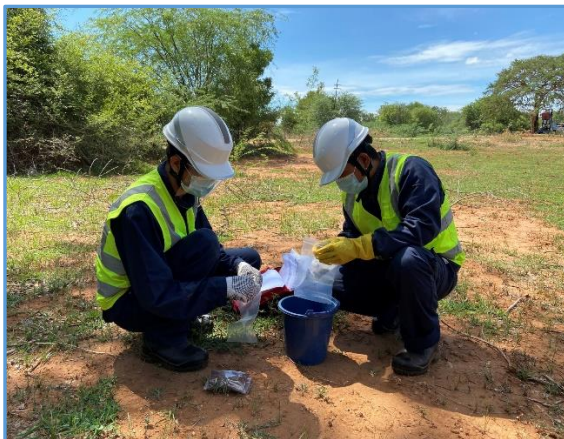
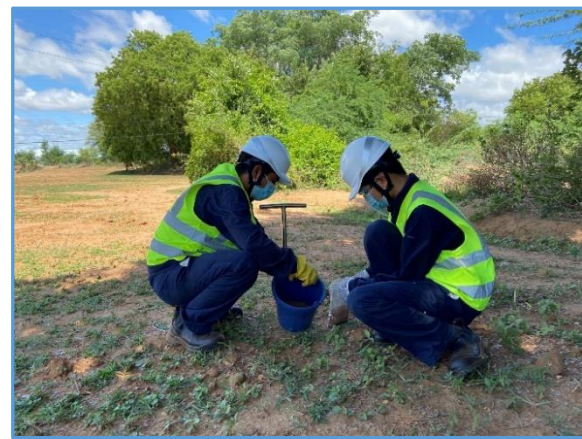
Figure 43: Soil Sampling Location (July - 2020)

In the course of the survey, sampling procedures, sample preservation and sample analysis were all recommended in the standard operating procedure of Myanmar NEQEG. In soil sampling, the standard agricultural sampler (Soil Auger) was applied. The sampler is a stainless steel tube that is sharpened on one end and fitted with a long, T-shaped handle. This tube is approximately three inches in diameter. To refrain from contamination, about 20 – 30 cm of topsoil was removed by the sampler before sampling. Then the sample was taken and collected in a clean plastic bag. Chemical preservation of samples was not applied because it is generally not recommended by the standard method. Samples were cooled in an ice box which temperature was under 4°C. Samples were protected from sunlight to minimize any potential chemical reaction. Soil texture and colour were also recorded upon sampling.

The soil sampling locations were chosen as close as practicable to the existing oil wells within Mann Field. For safety reasons, underground utilities inspection was conducted at the proposed borehole location jointly with the staff from MOGE before soil sampling. Details of the monitoring location are shown in Table 12 and illustrated in Figure 42. The surrounding environment of the soil sampling stations and soil condition are shown in Table 13. These survey points were also chosen to represent baseline soil quality within the wider Mann Field area where the Project will be implemented.

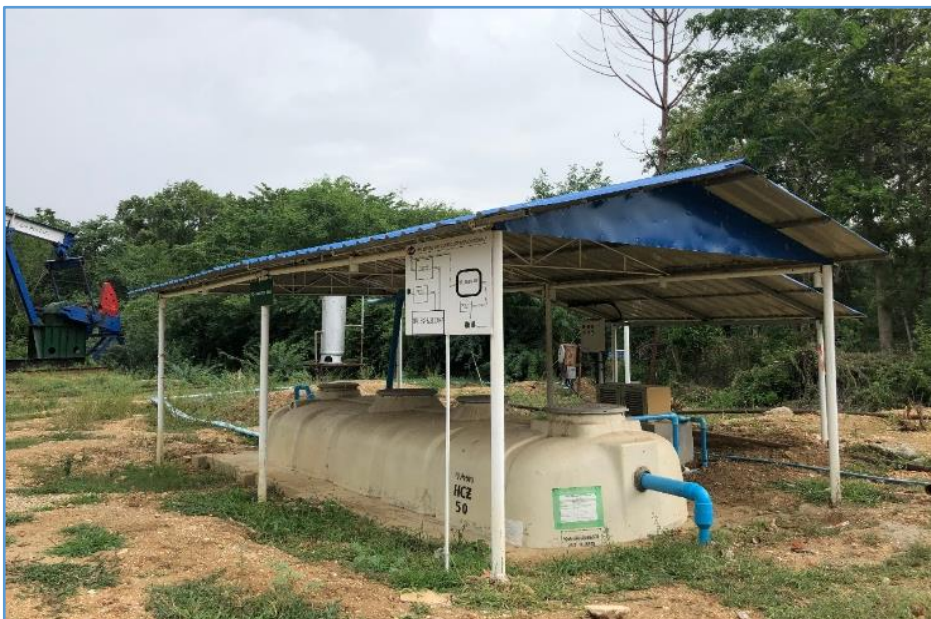
Figure 46: Bio-Filtration Unit

Sanitary wastewater and domestic wastewater are implemented as per the mitigation plan.

Performing maintenance and inspection for Bio filtration unit by authorized person from WM Water Company.

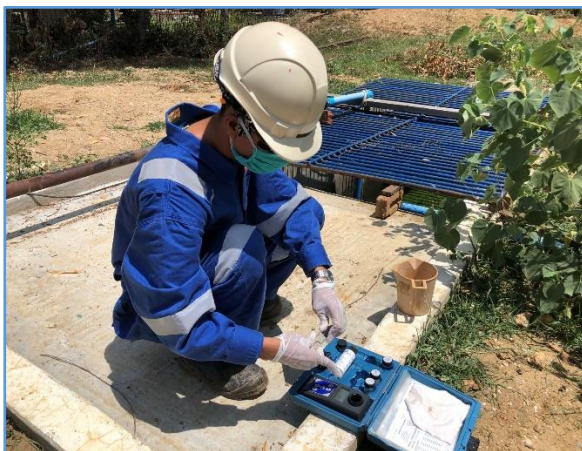
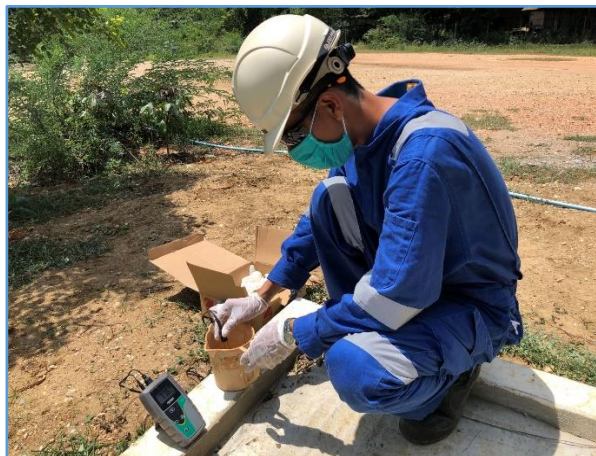
Figure 51: Monitor Waste Water Discharge Parameters

Sr.	Analysis	Results	Units	NEQEG Guideline	Remarks
1	pH	7.6	S.U	6.0 ~ 9.0	Normal
2	Temperature	23.0	°C		
3	Total Suspended Solids	4	mg/l	50	Normal
4	BOD ₅	16	mg/l	30	Normal
5	COD	35	mg/l	125	Normal
6	Total Phosphorus	<0.02	mg/l	2	Normal
7	Oil and Grease	8	mg/l	10	Normal
8	Total Nitrogen	<5	mg/l	10	Normal-
9	Turbidity	<5	FAU	-	
10	Electrical Conductivity (EC)	0.9	mS/cm	-	
11	Total Coliform Bacteria	-		400

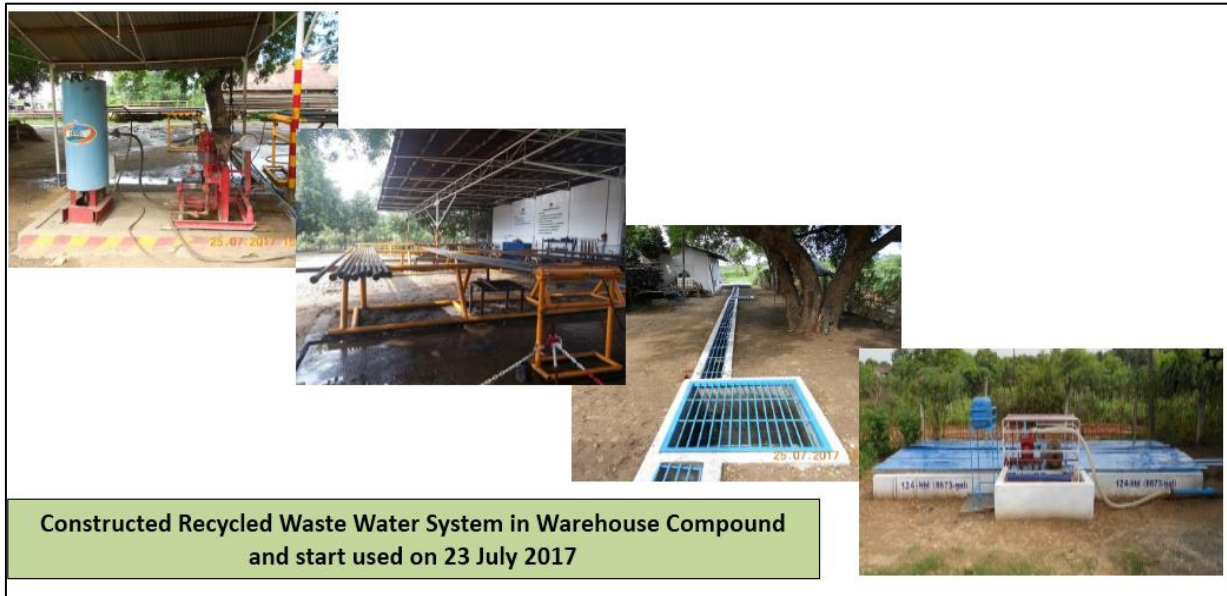
Figure 52: Recycle Water Usage System with Zero Discharge

In Mann field warehouse, team used to perform the hydro test for the tubing in the designated pressure test area. Field team reduced and minimized the usage of water volume by using recycled water with zero discharge.

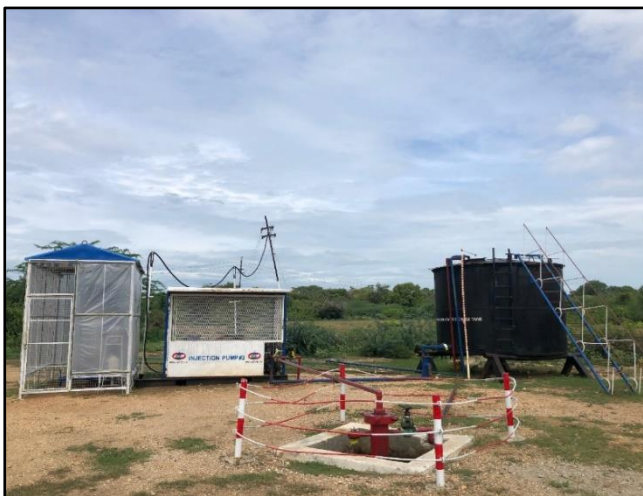
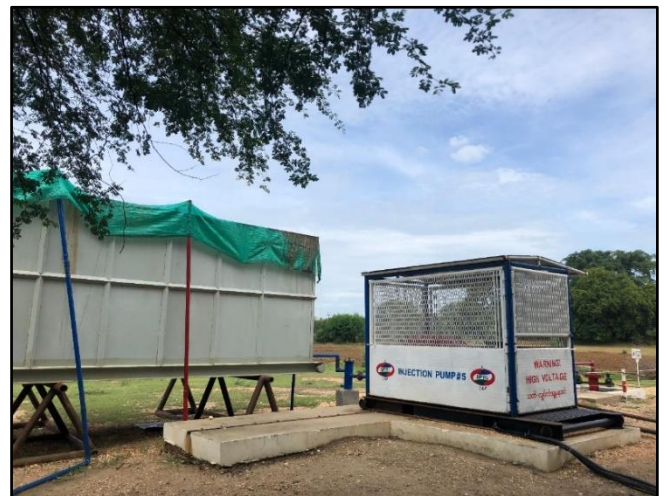
Figure 58: Produced Water Injection Pump

As per the table 8.3 Environmental And Social Monitoring Program of the approved EIA report, it is committed to test the waste waters from the discharged points. However, all the produced water from the GOCs are being disposed back into the formation and thus there is no discharged to the environment. Again, there is no discharge from the hydro test activities and also from shut in wells.

Produced water generated from everyday production about +/- 1400 BBL per day in the Mann Field. Produced water typically contains a mixture of inorganic (dissolved salts, trace metals, suspended particles) and organic (dispersed and dissolved hydrocarbons, organic acids) compounds. Produced water generates sludge due to the compound sediments, and improper discharge sludge may cause potential impacts on the receiving environment (i.e. soil, surface water, and groundwater) and community health as well as terrestrial and aquatic ecological resources.

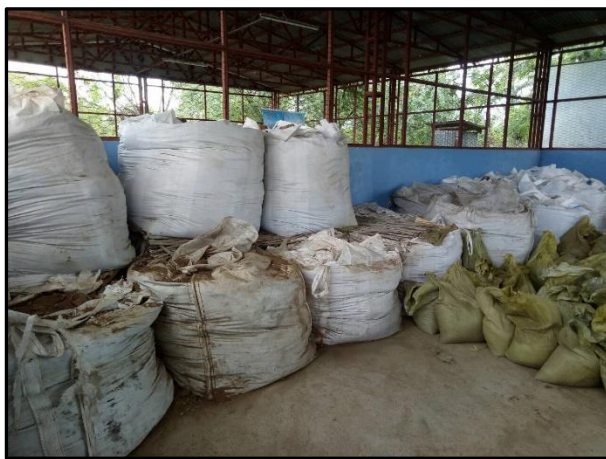
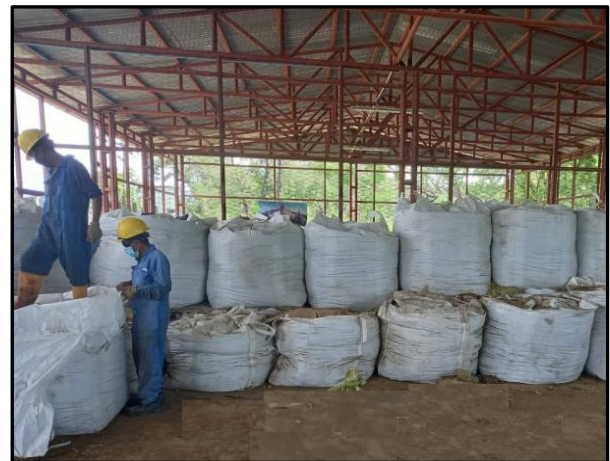
Figure 59: Dry Sludge Storage Area (Waste Management Compound)

Dried sludge, 40 Ton (estimated weight) are temporary storage at Waste Management Compound and we have planned to construct the temp storage area in the Sludge management compound and also will perform a pilot test with Bioremediation process. Currently, all sludge is proper storage in concrete pits.

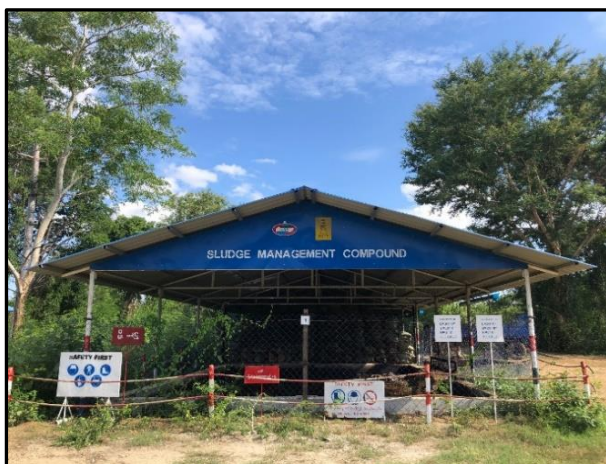
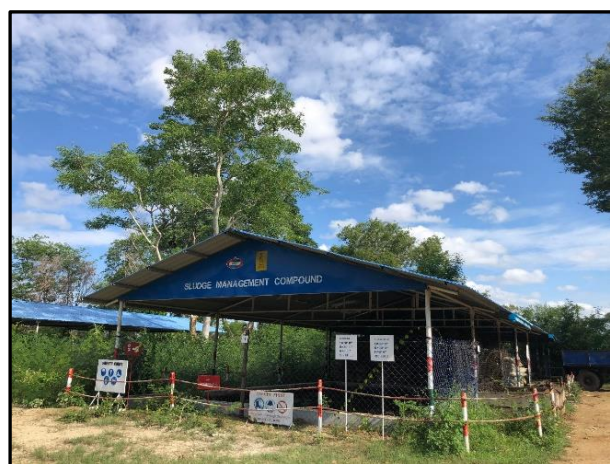
Figure 60: Sludge Management Compound

All sludge collected are in proper storage in concrete pits to meet the guideline levels in NEQEG for Onshore Oil and Gas Development.

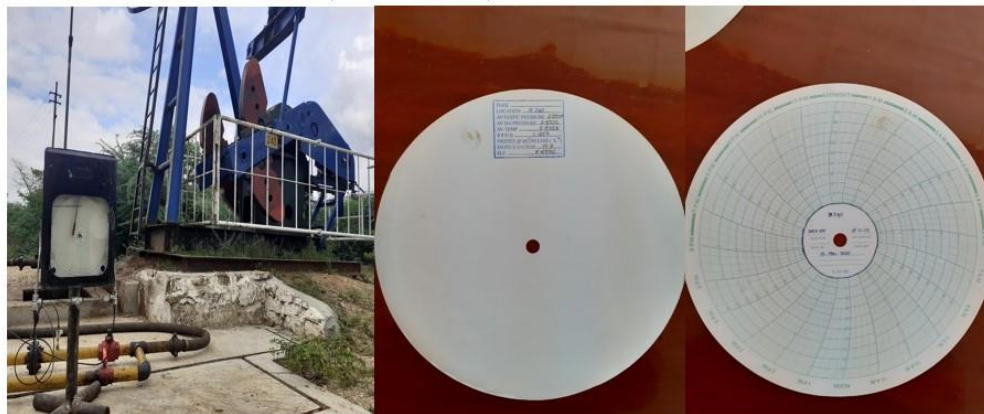
Gas Volume Measurement (Orifice Meter) Well- 240

Date : 10 March 2020, Gas Volume – 0 MMCFD

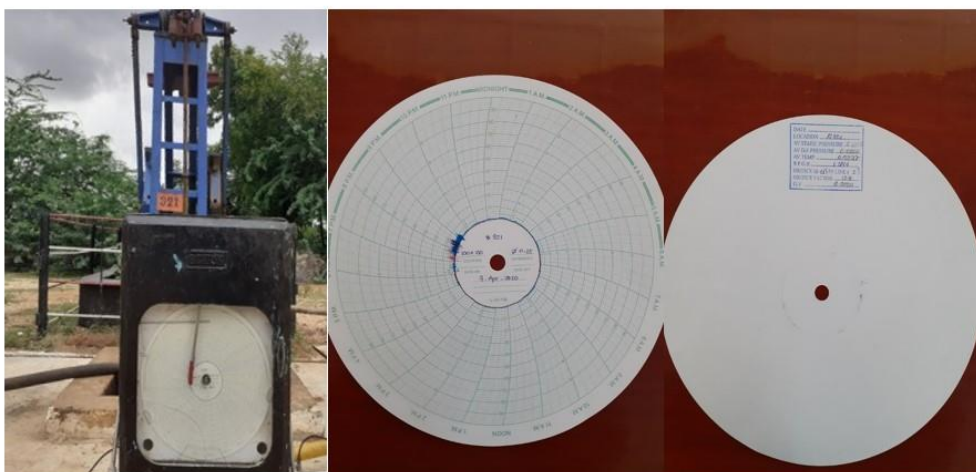
Gas Volume Measurement (Orifice Meter) Well- 321

Date : 7 April 2020, Gas Volume – 0 MMCFD

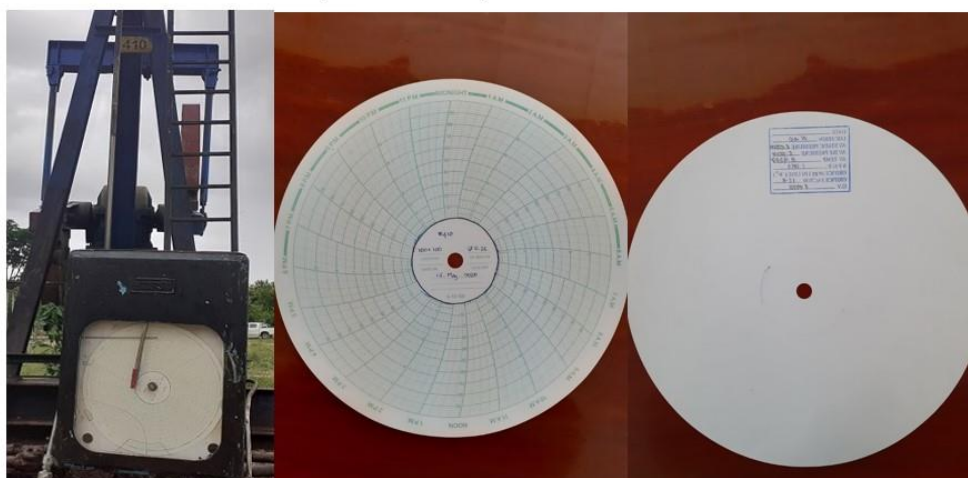
Gas Volume Measurement (Orifice Meter) Well- 410

Date : 13 May 2020, Gas Volume – 0 MMCFD

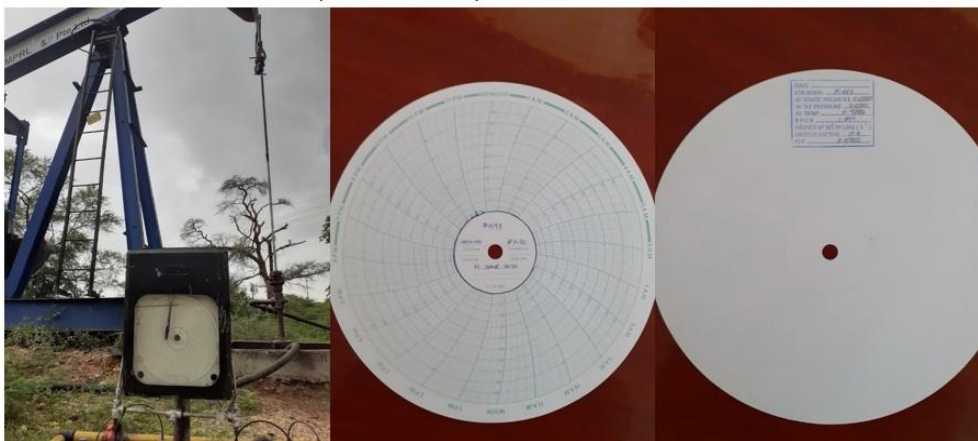
Gas Volume Measurement (Orifice Meter) Well- 493

Date : 17 June 2020, Gas Volume – 0 MMCFD

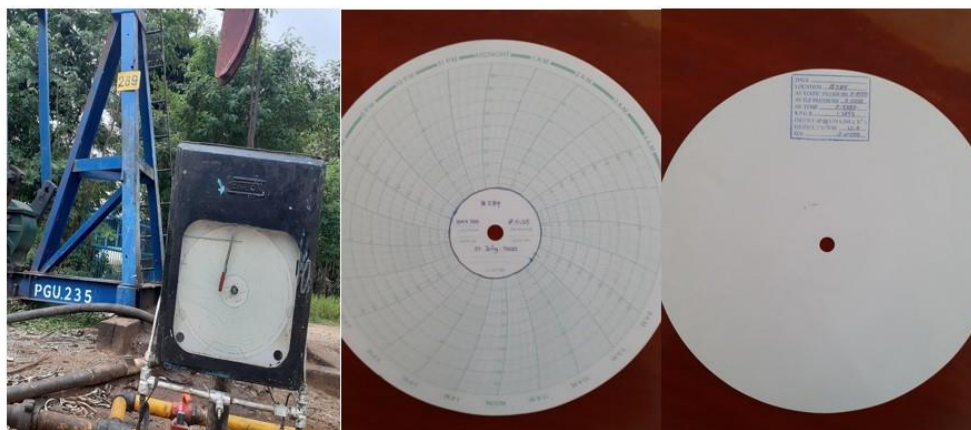
Gas Volume Measurement (Orifice Meter) Well- 289

Date : 21 July 2020, Gas Volume – 0 MMCFD

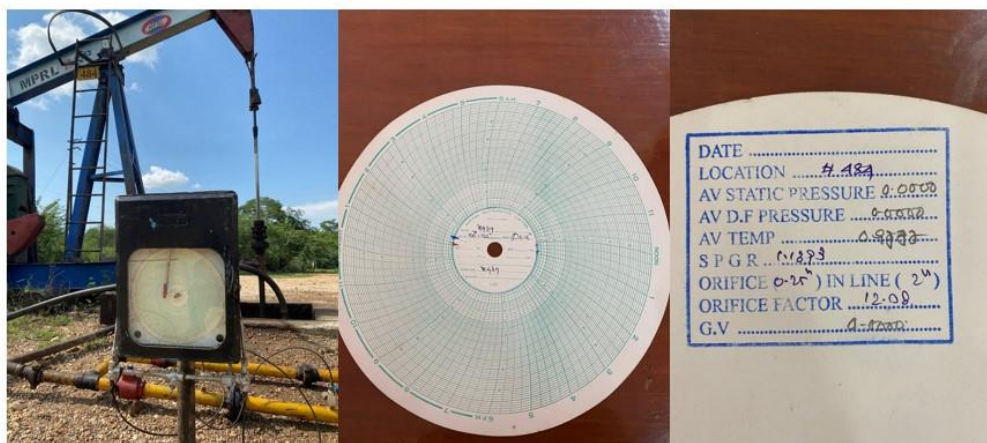
Gas Volume Measurement (Orifice Meter) Well- 484

Date : 6 Aug 2020, Gas Volume – 0 MMCFD

As per the reservoir nature, the gas volume will be slightly going down however there is a significant increase of gas volume after perforation the well # 657. However team is continually monitoring the gas volume by using the Echo meter for every vent well, which will measure the orifice meter and collect to the LPG supply lines if currently there is no additional impact due to gas venting and H₂S to the environment.

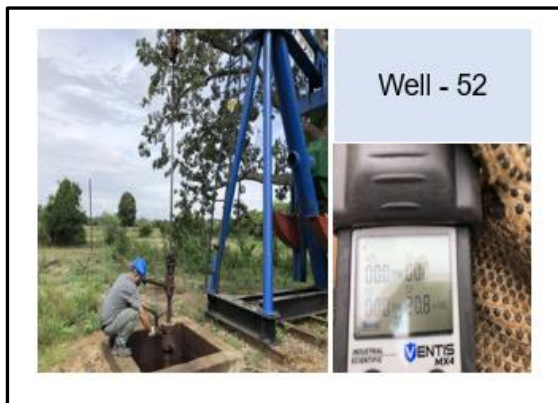
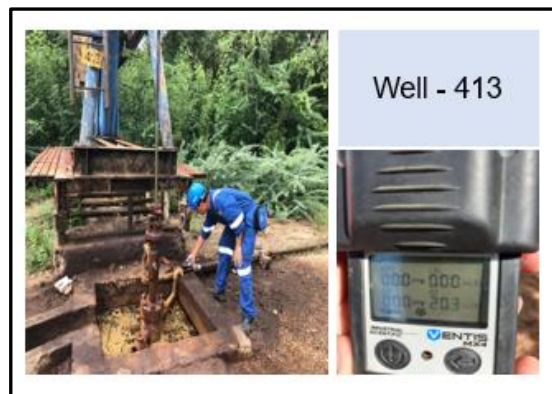
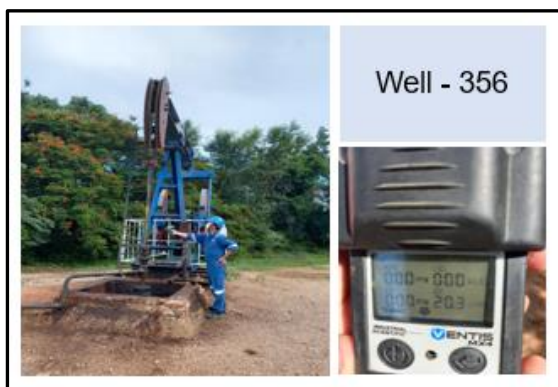
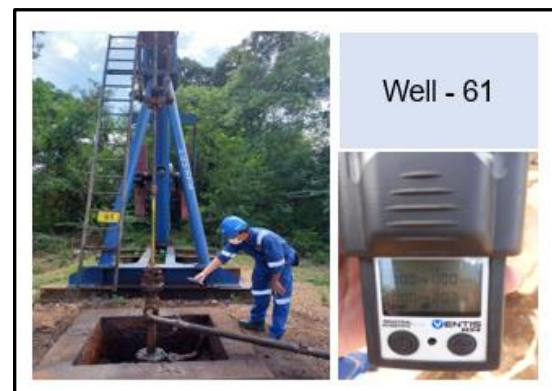
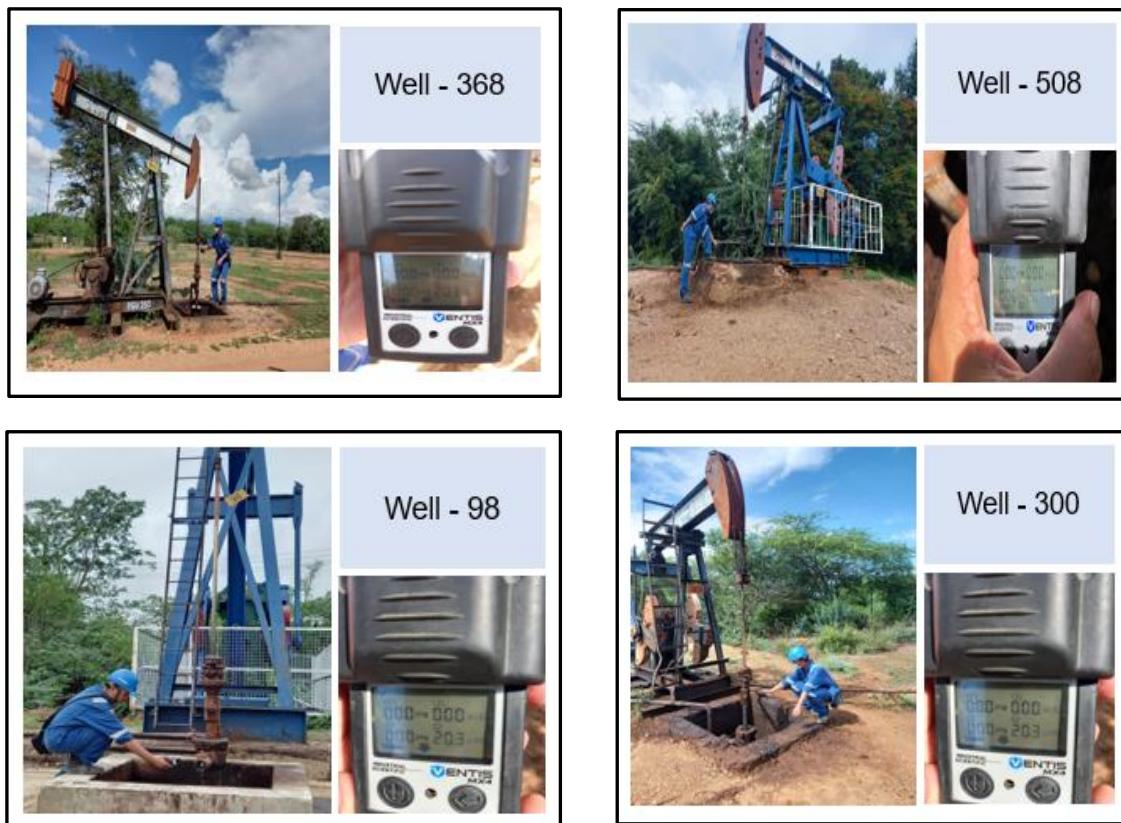
Figure 63: H₂S Monitoring Wells

Sr. No:	Well No.	Date	Measurement Time	H ₂ S (PPM)	CO (PPM)	O ₂ (%)	LEL (%)
1	M-52	04-Aug-20	9:40	0	0	20.9	0
2	M-413	04-Aug-20	9:00	0	0	20.3	0
3	M-61	04-Aug-20	14:40	0	0	20.9	0
4	M-356	04-Aug-20	10:00	0	0	20.9	0
5	M-368	04-Aug-20	15:20	0	0	20.3	0
6	M-508	04-Aug-20	16:00	0	0	20.7	0
7	M-98	04-Aug-20	10:13	0	0	20.9	0
8	M-300	04-Aug-20	14:50	0	0	20.9	0

Measurement duration – 30 second / Guideline Value – Hydrogen Sulphide 5 mg/ Nm³ c

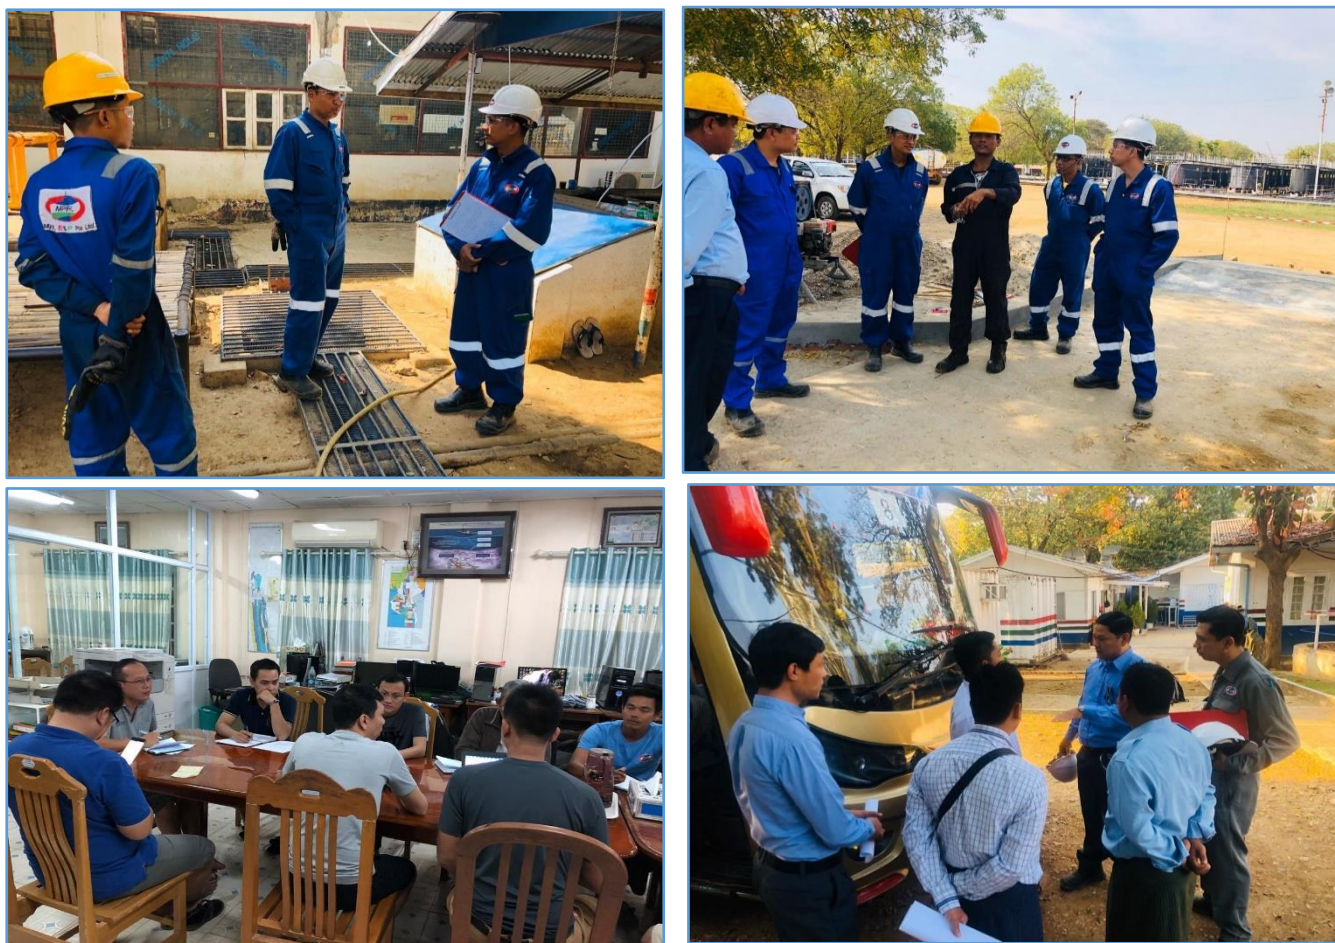
Figure 67: HSE Team site audit photos

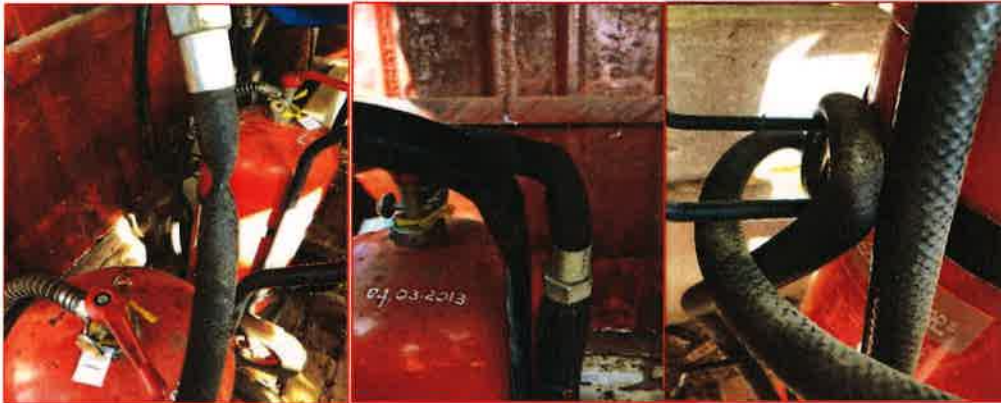
Observation	Recommendations	Priority Level	Action Parties	Target Date
50 kg extinguishers	<ul style="list-style-type: none"> To replace with new fire extinguisher 	P2	HSE Dept	50% replace in end of April 2020 and next 50 % replace in end of April 2021

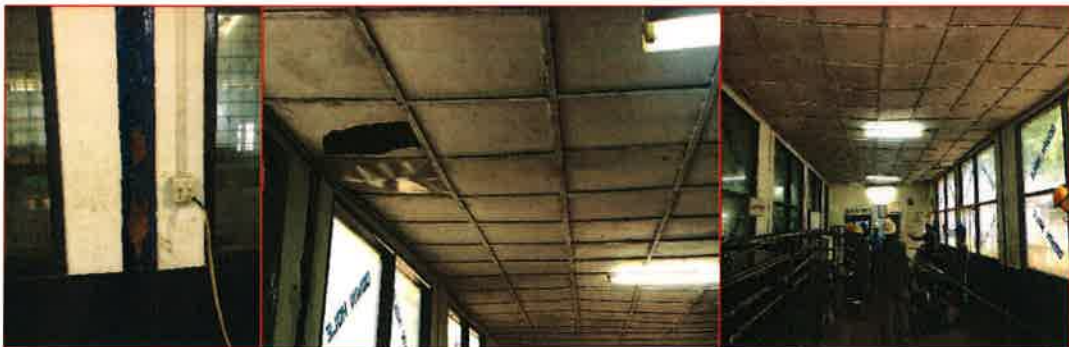
Observation	Recommendations	Priority Level	Action Parties	Target Date
Unsafe structure condition	<ul style="list-style-type: none"> To coordinate with MOGE to have the down-hole work shop structure repaired as necessary. 	P1	Field operation	Facilities of MOGE and On-Going

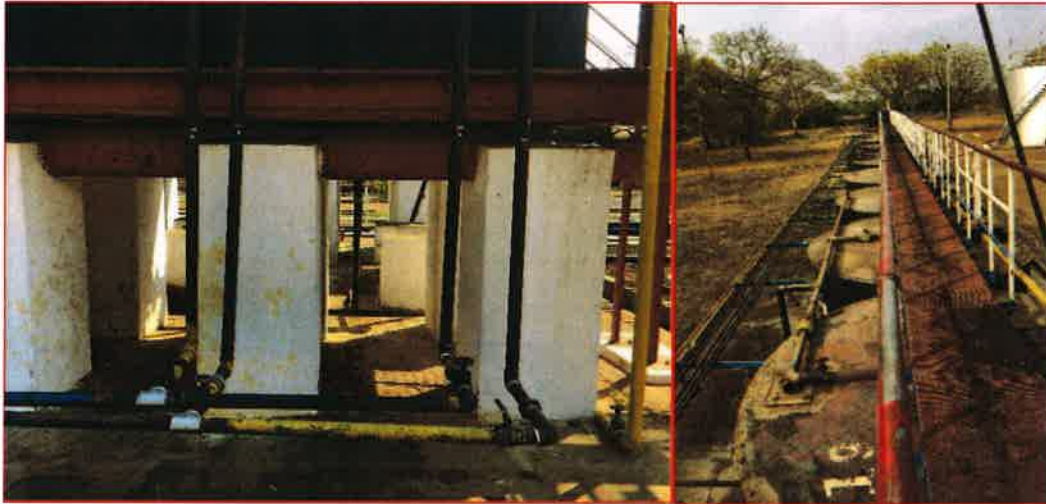
Observation	Recommendations	Priority Level	Action Parties	Target Date
Remaining 20 % valves relocation	<ul style="list-style-type: none">• This completely reduced and mitigated the risk of accessing to the dangerous area which has a high potential of falling from height	P1	Field operation	30 Sep 2020

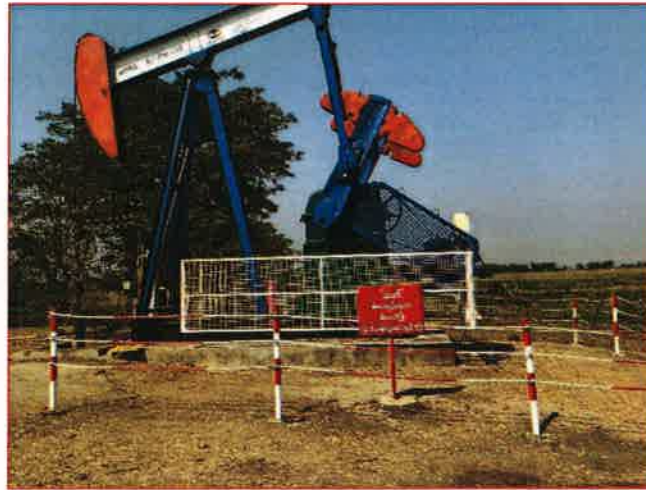
- 2.1 As a good practice and improvement, the pumping unit was fenced and barricaded which is closed to the community area, it can prevents potential harm to people or animal from entering into the dangerous area, as a risk reduction and mitigation measure. ✓

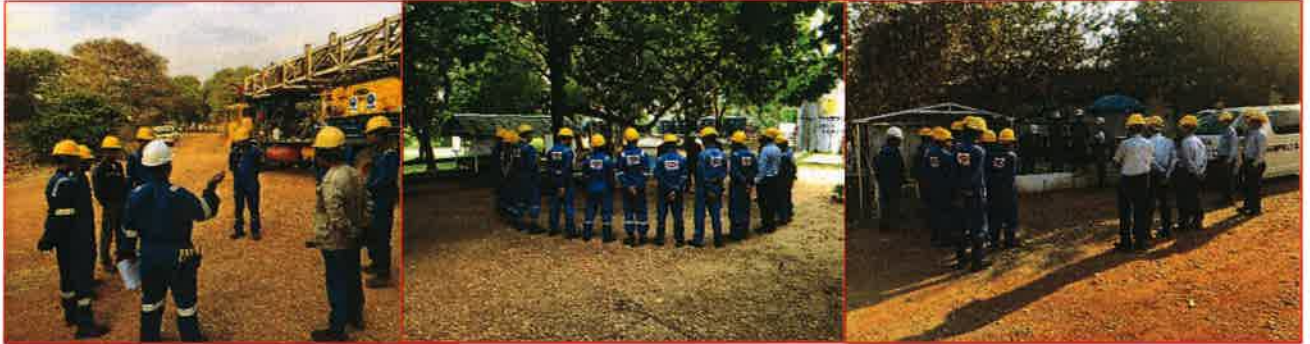
- 2.3 As a good practice and improvement in morning Tool Box Talk meeting, observed that the crews actively participated in the meeting and shared their own experiences effectively. Congratulations to all crews in Mann Field. ✓

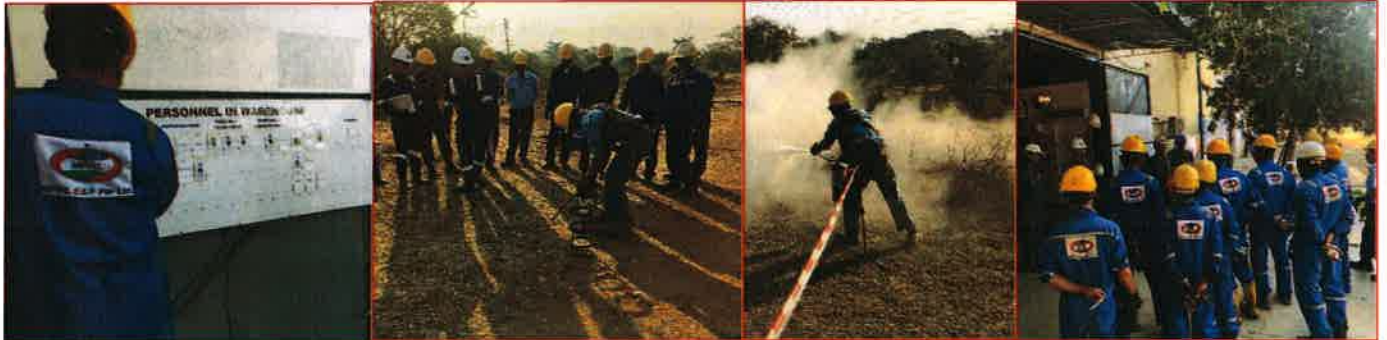
- 2.4 As a good practice and improvement, emergency drill. Observed the crews are know their roles and responsibilities in an emergency situation as per procedures. ✓

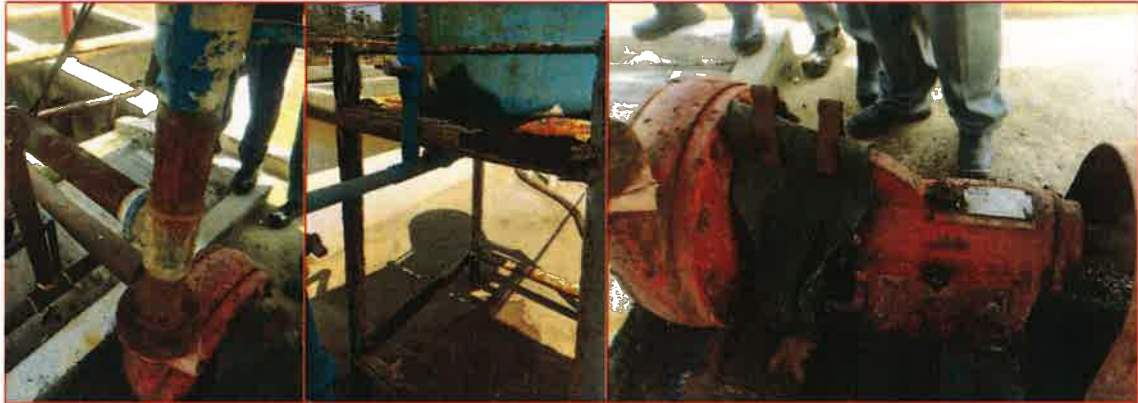
Observation	Recommendations	Priority Level	Action Parties	Target Date
Corrosion pipework at GOCS - 1	<ul style="list-style-type: none">To prevent corrosion by regular maintenance program	P2	Field operation	30 Sep 2020
