Environmental Monitoring Report

April ~ September 2020

for Redevelopment and
Enhanced Oil Recovery (EOR)
Programme

MPRL E&P Pte Ltd.

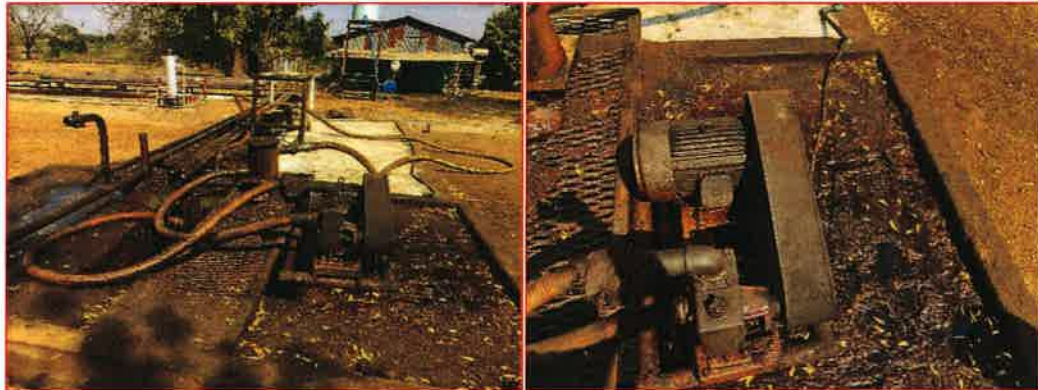
Observation	Recommendations	Priority Level	Action Parties	Target Date
GOCS-2, Bowser Oil Transfer Pump	<ul style="list-style-type: none"> Recommend to conduct engineering study and implement the control action to prevent fire and explosion hazard. 	P1	Field operation & Engineering	31 March 2021

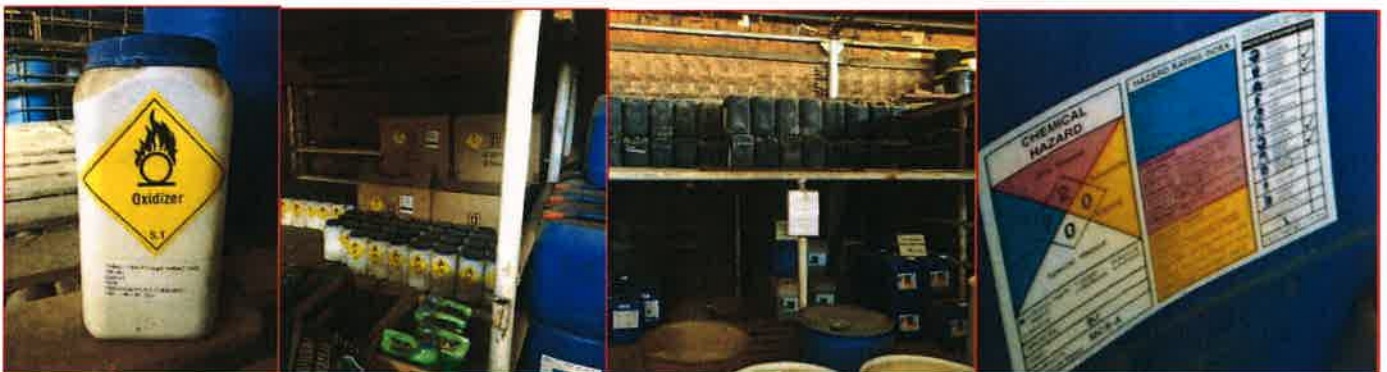
Observation	Recommendations	Priority Level	Action Parties	Target Date
Warehouse Chemical Store flammable liquid stored are together with oxidizer	<ul style="list-style-type: none"> Oxidizers must be segregated from organic material, flammables, combustibles and strong reducing agents such as zinc, alkaline metals, and formic acid. To review the whole chemical management storage system at Warehouse. 	P2	Warehouse & End-users	30 Sep 2020

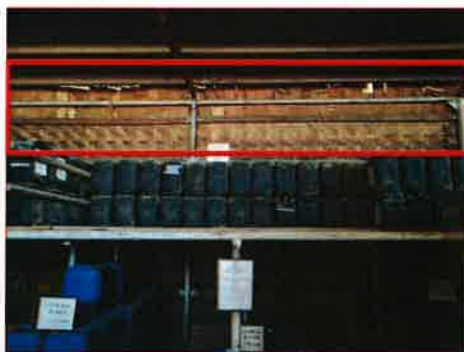
Observation	Recommendations	Priority Level	Action Parties	Target Date
Chemical Warehouse wall	Recommend to replace with gypsum walling which has the best fire resistant rating.	P2	Field Operation	30 Sep 2020

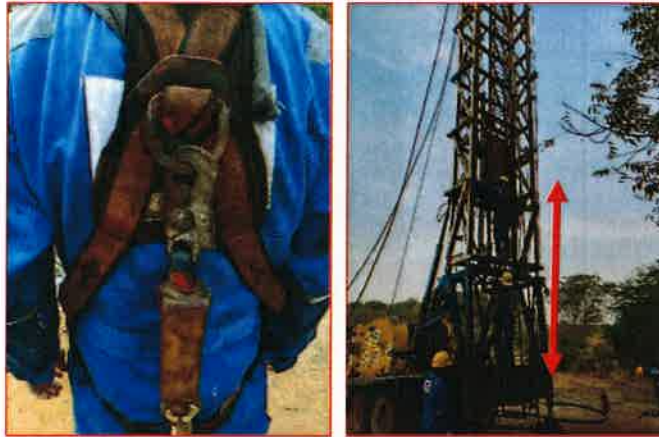
Observation	Recommendations	Priority Level	Action Parties	Target Date
Full body harness	<ul style="list-style-type: none"> To replace with new body harness with double lanyard. After the high work activities, recommend properly stored by keeping it free of moisture, protected from impact and away from extreme temperatures 	P1	Field Operation Team	Done

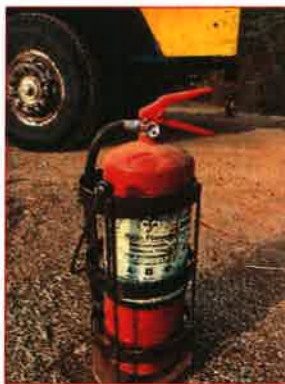
Observation	Recommendations	Priority Level	Action Parties	Target Date
Fire Extinguisher Inspection Frequency	<ul style="list-style-type: none"> To increase the frequency of inspection from quarterly to monthly. 	P1	HSE	30 April 2020

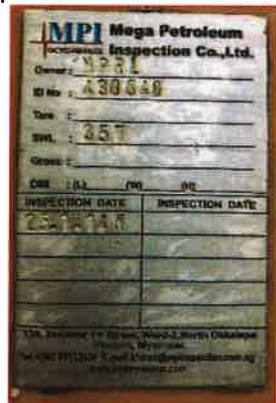
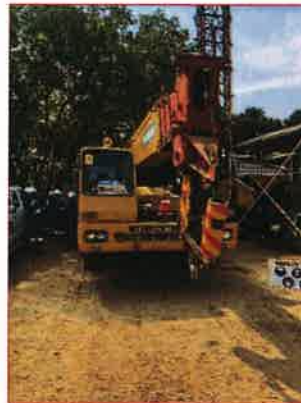
Observation	Recommendations	Priority Level	Action Parties	Target Date
JSA	<ul style="list-style-type: none"> Regular inspections shall be carried out by a competent person or third party 	P2	HSE & Field Team	30 May 2020

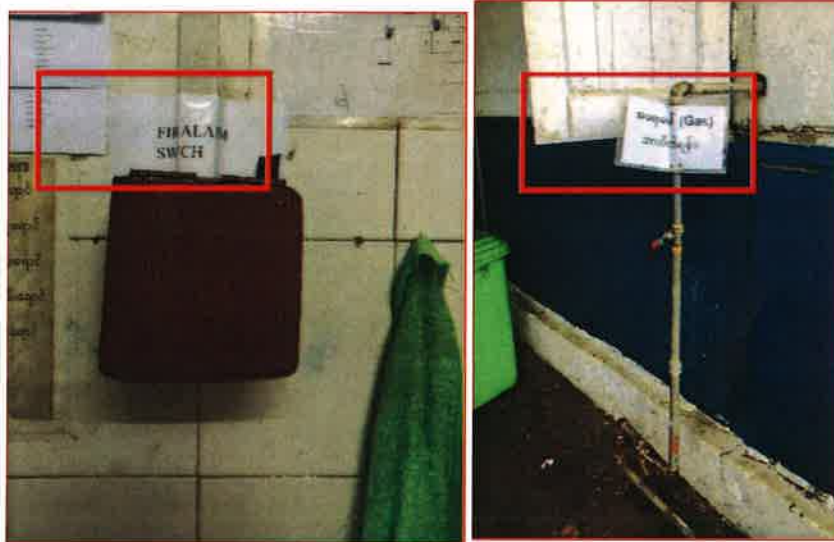
Observation	Recommendations	Priority Level	Action Parties	Target Date
Proper Sign	<ul style="list-style-type: none"> To provide proper sign for fire alarm and emergency gas shut off valve. To train all related crews on the use of those provision measures. 	P2	Field Operation Team	30 Apr 2020
