# Environmental Monitoring Report

**for Redevelopment and  
Enhanced Oil Recovery (EOR)  
Programme**

October 2021 – March 2022

MPRL **E&P** Pte Ltd.

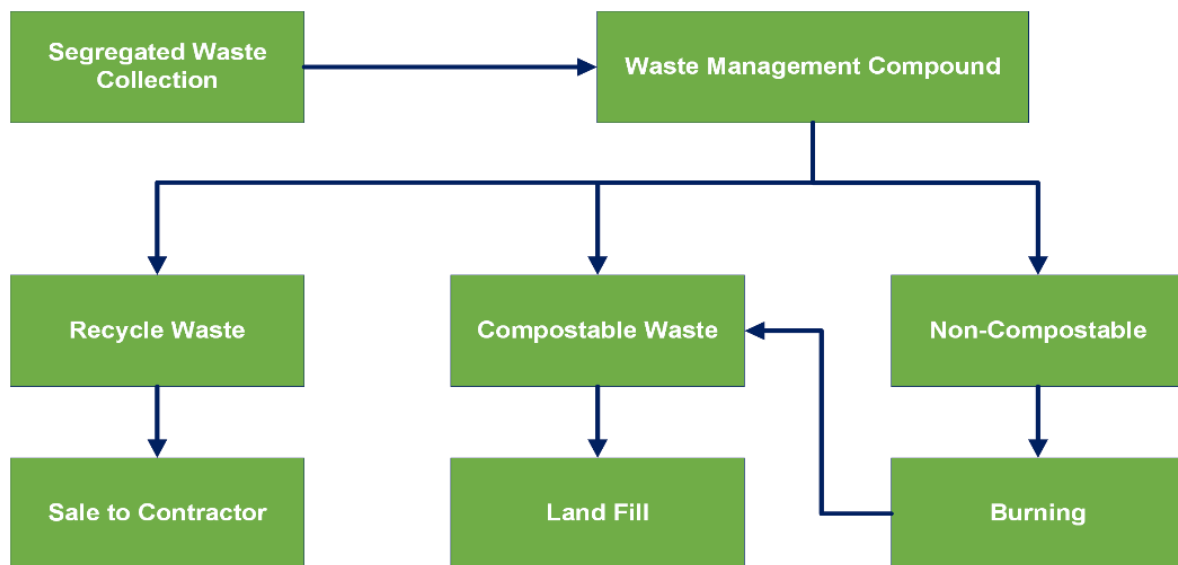
*Figure 2: Waste Management Flowchart*

- Waste is segregated into hazardous, general and recyclable waste within suitable bins that are clearly labelled;
- Bins/drums are sent to the approved disposal location. Each bin/drum is labelled with the waste typewritten;
- Each waste bin/drum sent is included on the backload manifest; and
- Waste transportation is recorded in the waste database.

Brief Waste Management Process is described as follows:

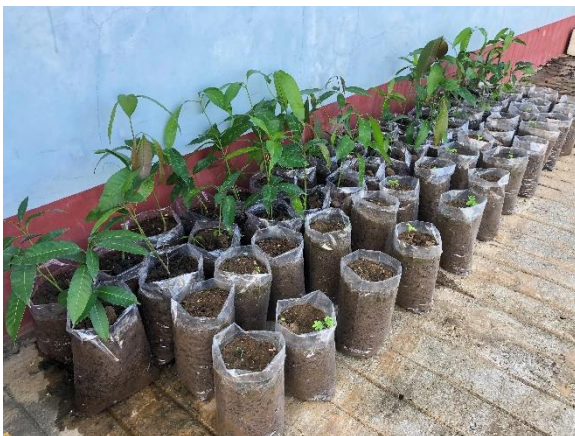
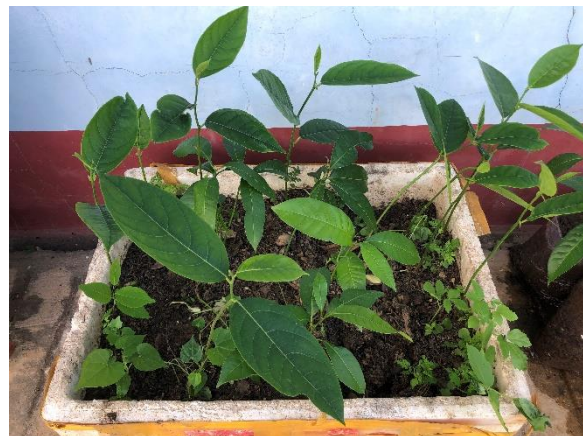
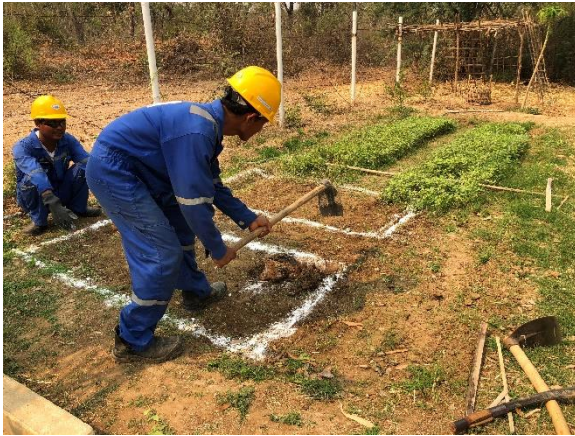
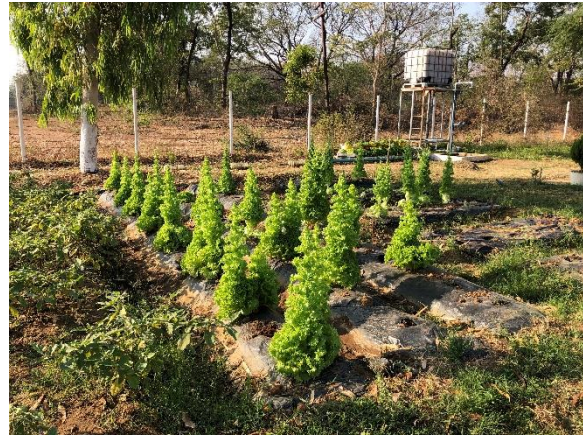
*Figure 4: Composting Waste Used in Plantation Process at WMC*

According to our six-months self-monitoring records, from October 2021 to March 2022, the composting process is produced about 1540 kg. This process is very fast in the summer but in the rainy season, the composting bacteria do not properly work best under neutral conditions.

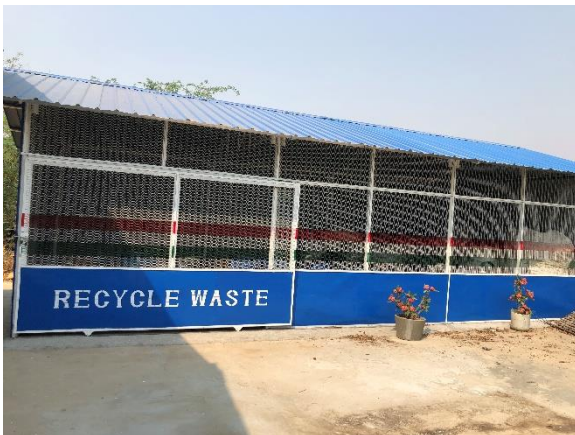
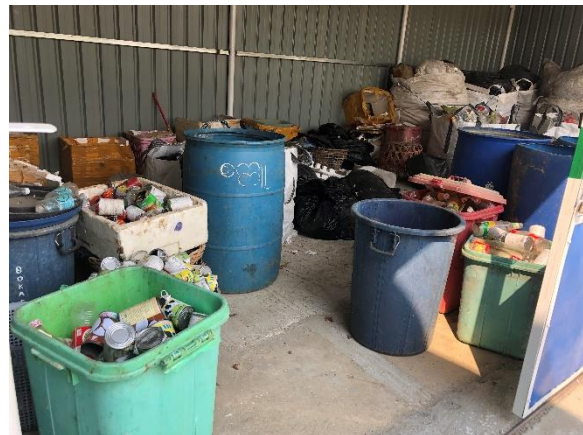
*Figure 5: Recycle Waste Storage Area*

Recycling materials such as glass, paper and cardboard, plastic bottles, and metals, are collected and sold out to the third party. Recycling materials are collected and separated from general waste.

General Waste collection from all areas in the Mann Field Operations and temporary storage at Waste Management Compound. The field team managed cleaning and disposing of the general waste by using Jambo Bags and dispensing to designated area.

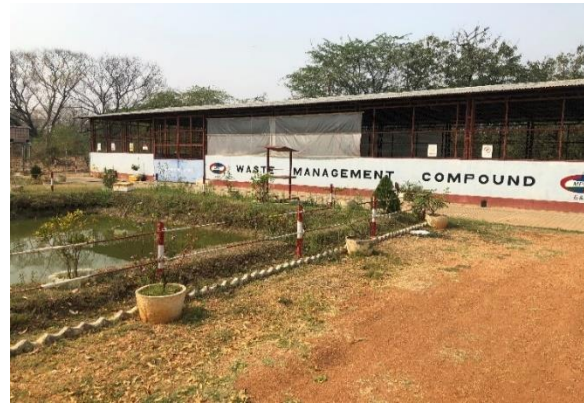
**Figure 6: Waste Management Compound (WMC)**

Recycle waste has been registered using the 'Waste Register' form including specific details as to the type and quantity of waste.

Recycle waste that is going to be sent to a selected third party for adequate disposal has to be monitored using the "Waste Disposal Contractor Approval" form which was approved by the Field Operations Manager and or Site HSE Officer.

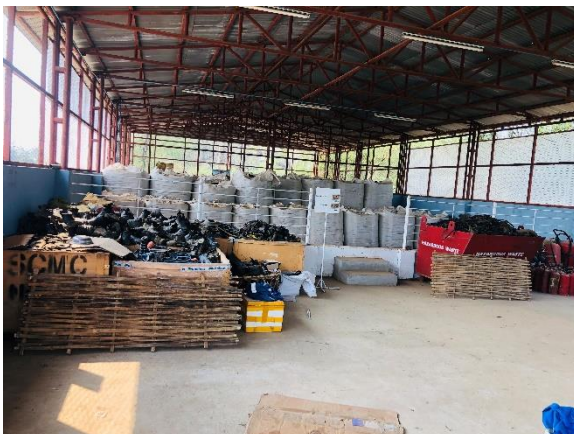
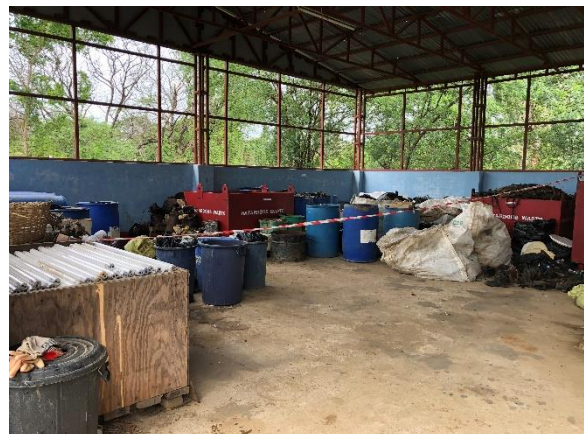
**Figure 7: Hazardous Waste Storage Area**

Hazardous Waste, 1303 kg is collected from all work-related areas and is proper storage at Waste Management Compound. Now preparing work order processes with GOLDEN DOWA ECOSYSTEM for adequate disposal method.

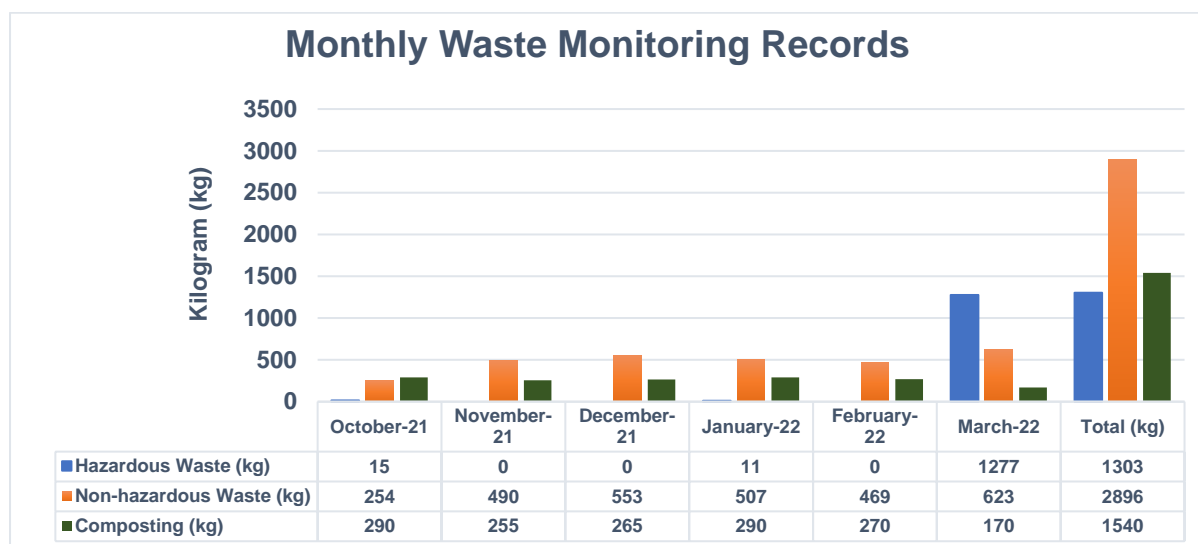
**Figure 8: Monthly Waste Monitoring Records from Oct-21 to Mar-22**

Month	Hazardous Waste (kg)	Non-hazardous Waste (kg)	Composting (kg)
October-21	15	254	290
November-21	0	490	255
December-21	0	553	265
January-22	11	507	290
February-22	0	469	270
March-22	1277	623	170
<b>Total (kg)</b>	<b>1303</b>	<b>2896</b>	<b>1540</b>

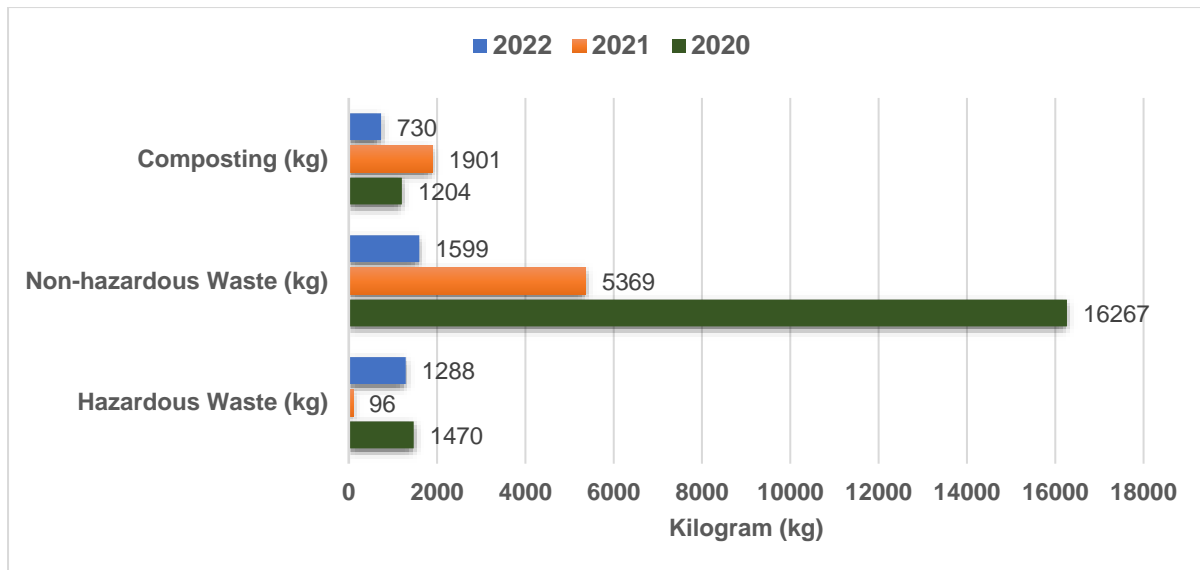
*Figure 9: Yearly Waste Monitoring Records from 2020 to 2022*

Month	Hazardous Waste (kg)	Non-hazardous Waste (kg)	Composting (kg)
2020	1470	16267	1204
2021	96	5369	1901
2022	1288	1599	730

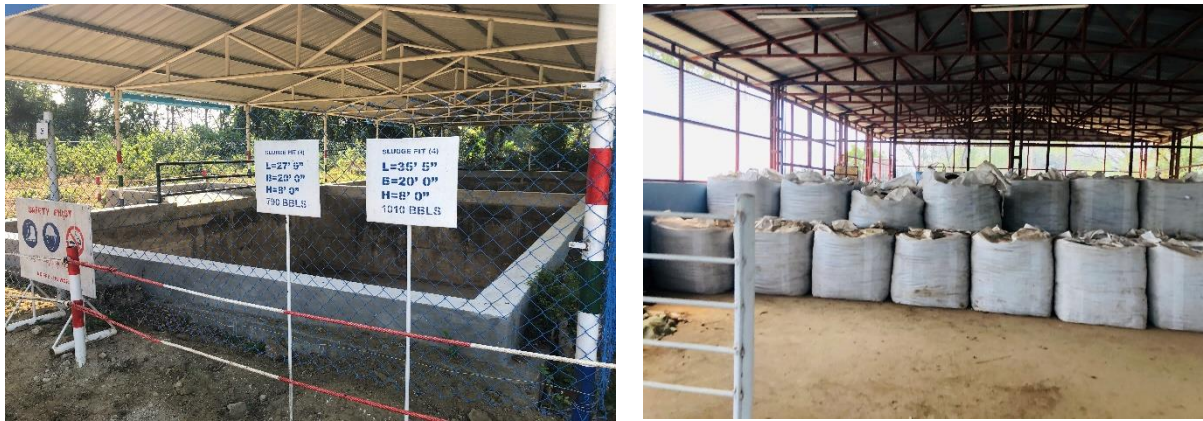
**Figure 19: Sludge Storage Pits**

Dried sludge, 43,930 Kg (estimated weight) is temporary storage at Waste Management Compound and we have planned to construct the temp storage area in the Sludge management compound and also will perform a pilot test with the bioremediation process. Currently, all sludge is proper storage in concrete pits.

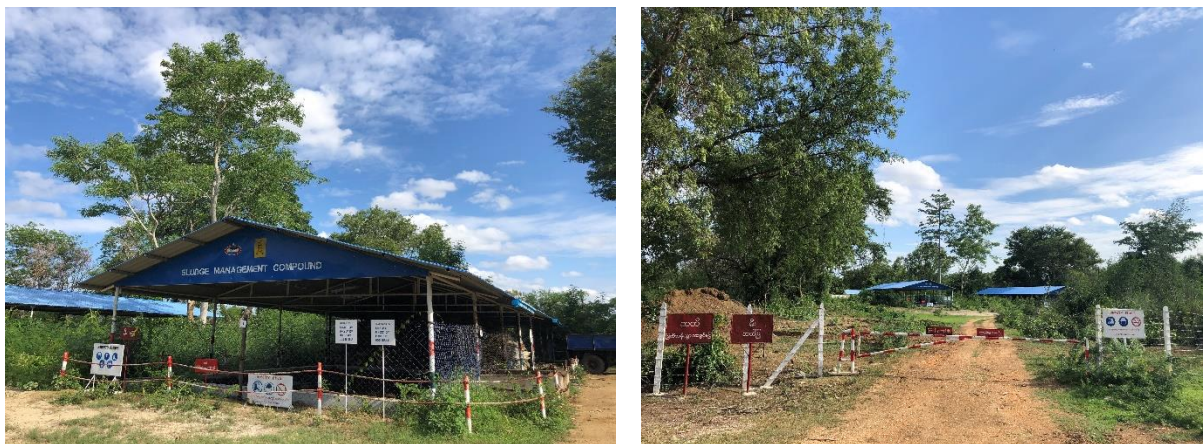
**Figure 20: Sludge Management Compound**

All sludge collected is in proper storage in concrete pits to meet the guideline levels in NEQEG for Onshore Oil and Gas Development.

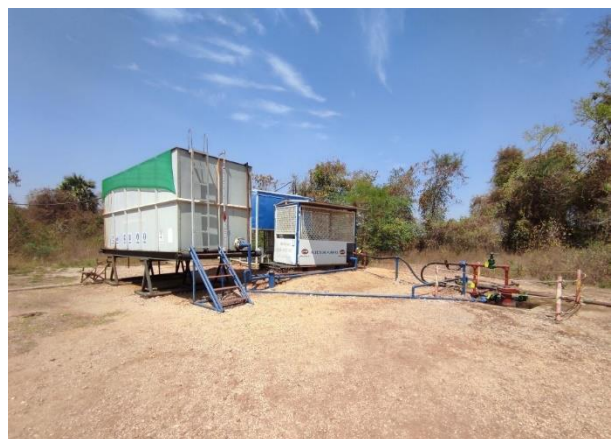
**Figure 21: Produced Water Injection Process**

MPRL E&P is undertaking to inject all produced water (100%) into the shut-in wells by using 5 units of injection pumps to meet guideline levels in NEQEG for Onshore Oil and Gas Development.

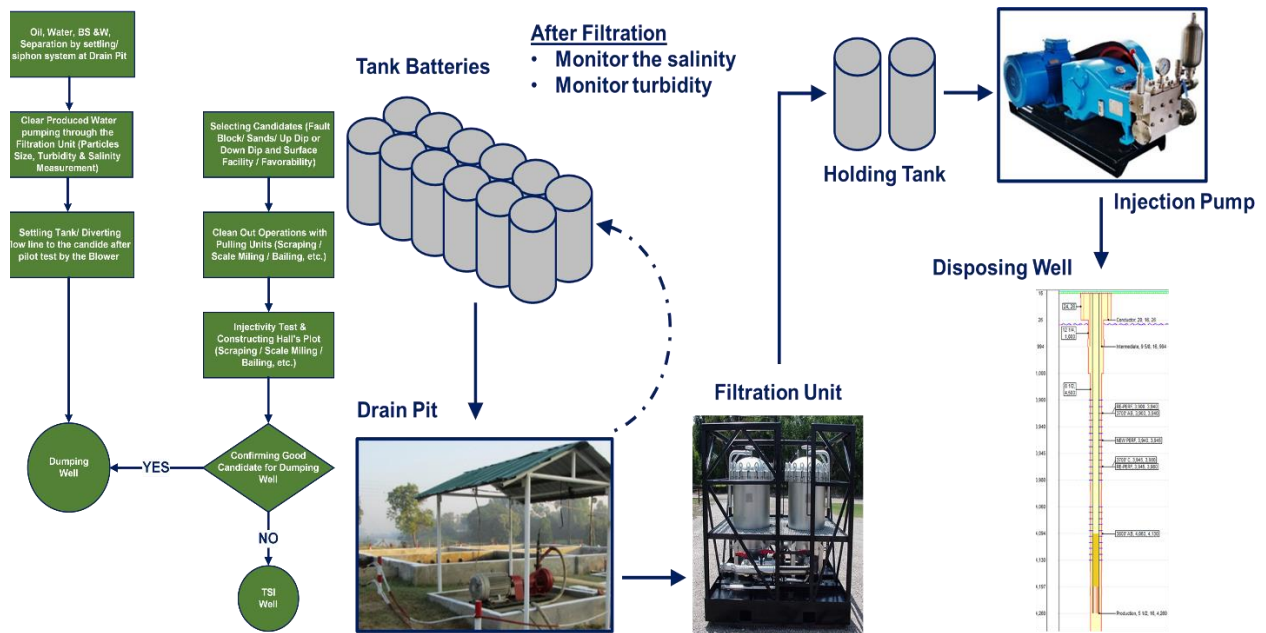
**Figure 22: Produced Water Management Process**

Produced water generated from everyday production of about 1400 BBL per day in the Mann Field. Produced water typically contains a mixture of inorganic (dissolved salts, trace metals, suspended particles) and organic (dispersed and dissolved hydrocarbons, organic acids) compounds. Produced water generates sludge due to the compound sediments, and improper discharge of sludge may cause potential impacts on the receiving environment (i.e. soil, surface water, and groundwater) and community health as well as terrestrial and aquatic ecological resources.

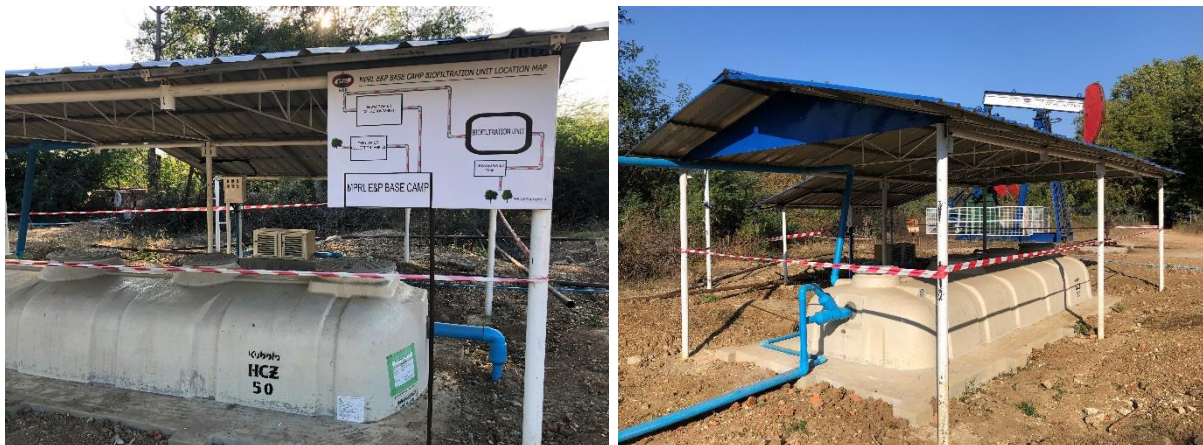
**Figure 24: Bio Filter Treatment System**

Domestic-type wastewater and sewage are under management in the existing operational phase. Based on the camp water consumption monitoring results, the sewage and wastewater generation rate is up to about 10,000 litres per day of sanitary wastewater is generated from the base camp within the Mann Field which can accommodate 80 – 100 workers.

Water consumption is monitored by using the water flow meter in the base camp, workshop, warehouse, and downhole workshop. In the meantime, the team is fully aware of the consumption of water to reduce the volume of water consumption.

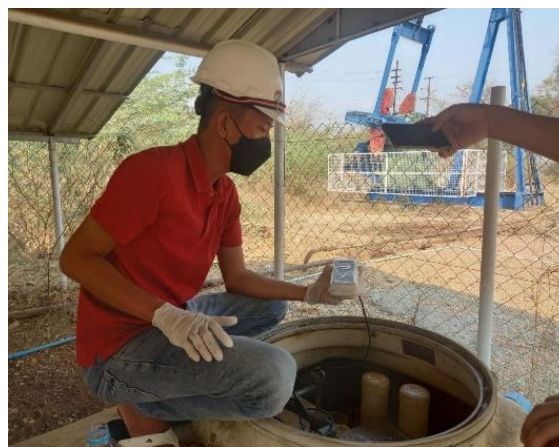
**Figure 25: Checking the Bio-filter Treatment from Supplier**

During the monitoring periods from October 2021 to March 2022, there was one-time monitoring conducted for the bio-filter water quality from the sewage treatment system. In December 2021, a total of eight (8) parameters were monitored the rest of the parameters were within the NEQEG except the total coliform bacteria parameter.

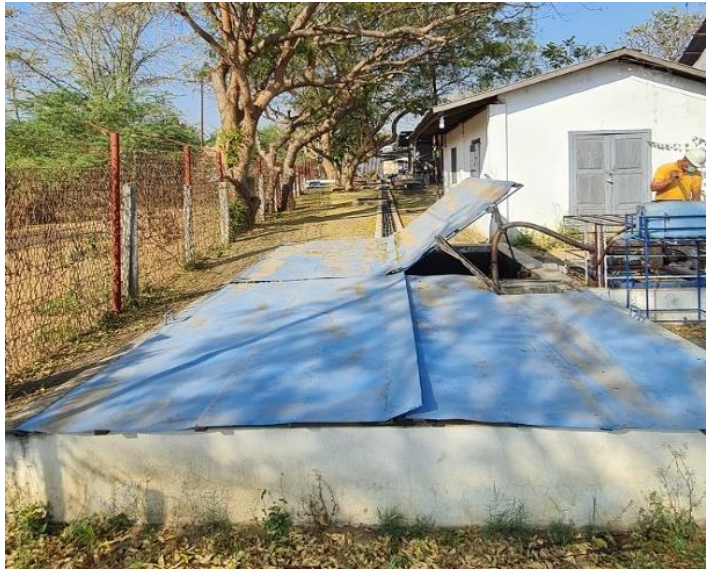
**Figure 28: Recycle Water Usage System with Zero Discharge in Warehouse**

In the Mann field warehouse, the team used to perform the hydro test for the tubing in the designated pressure test area. The field team reduced and minimized the usage of water volume by using recycled water with zero discharge.

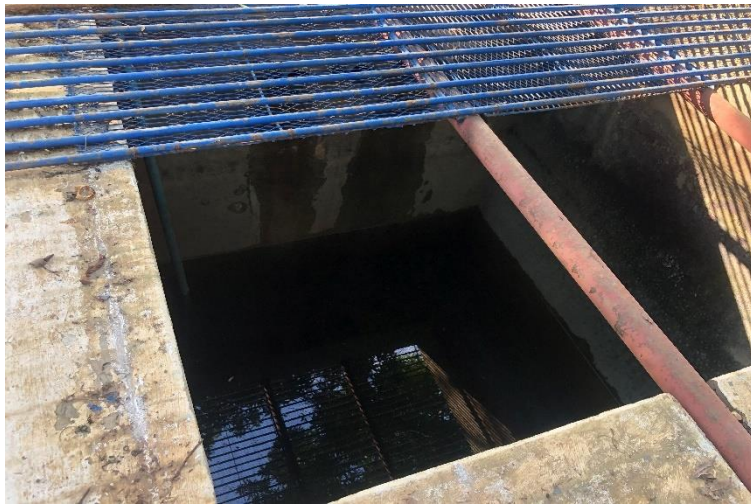
**Figure 29: Water Tank Condition**

**Downhole Workshop:** Downhole tools servicing, cleaning, inspection, pressure testing and the cleaning process with steam are carried out in the Downhole Workshop. The used water is disposed of at the zero discharge pits to preserve the environment.

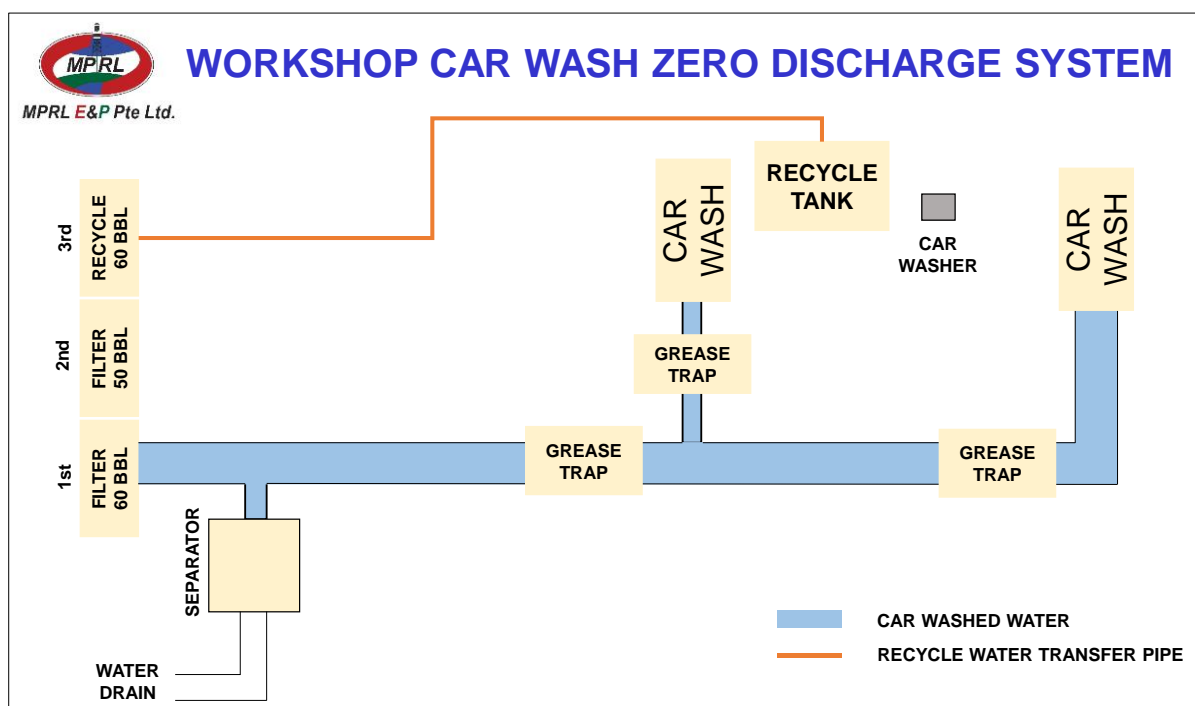
**Figure 31: Recycle Water Usage System with Zero Discharge in Mechanical Workshop**

**Mechanical Workshop:** Pulling units, workover rigs, trucks, bulldozers, backhoe, tractors and pumps are serviced in the workshop. Large amounts of water are used in car washes and general cleaning. Water reclaim systems are applied in the workshop.

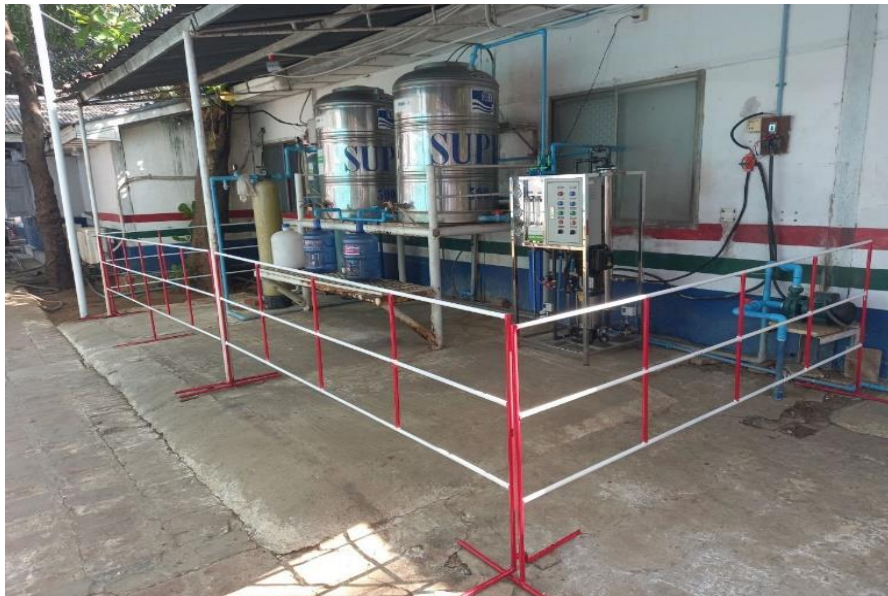
*Figure 32: Reverse Osmosis (RO) Treatment at Base Camp*

In the base camp, MPRL E&P installed a purified drinking water machine (Reverse Osmosis – RO System) for drinking and food preparation to cover enough consumption for all staff who are living in the base camp. The team is monitoring water quality quarterly and performing hygiene inspections and audits by the site doctor and HSE team as per the planned schedule.

The purified drinking water RO System was installed at the Base Camp for drinking and cooking purposes. In December 2021, the tested water from the RO outlet of purified drinking water system at Base Camp shows that total coliforms and fecal coliform are higher than NDWG (2019). Trying to identify the main cause of the results and plan to test again to ensure the results as per the sampling procedure. So, tested again raw water of purified drinking water.

As a monitoring result, total coliform and total fecal coliform was exceeded than NDWG and Reverse Osmosis (RO) treatment was temporarily suspended and MPRL E&P takes action for Safe Water of the drinking water purposes as the Camp base was using the purified water from the supplier and engaging with the supplier for root cause analysis. The supplier inspected that the RO membranes were required to replace and the treatment was necessarily required to upgrade. The newly RO treatment system was replaced and the service maintenance was completed on 24 March 2022 and the result shows there is no significant effect on the Drinking Water.

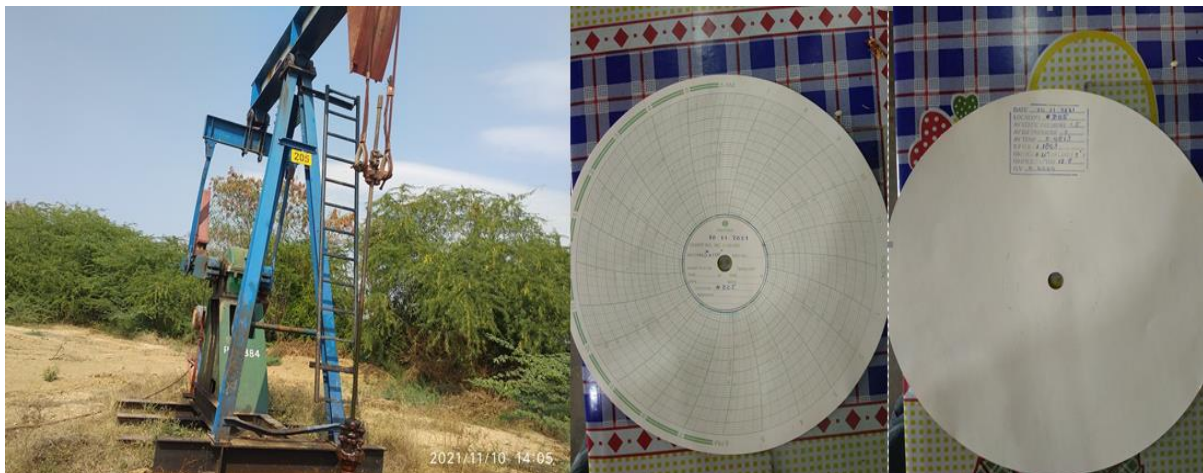
**Location** : Well – 205  
**Measurement** : Gas Volume Measurement by using Orifice Meter  
**Date** : 10 November 2021  
**Gas Volume** : 0 MMCFD

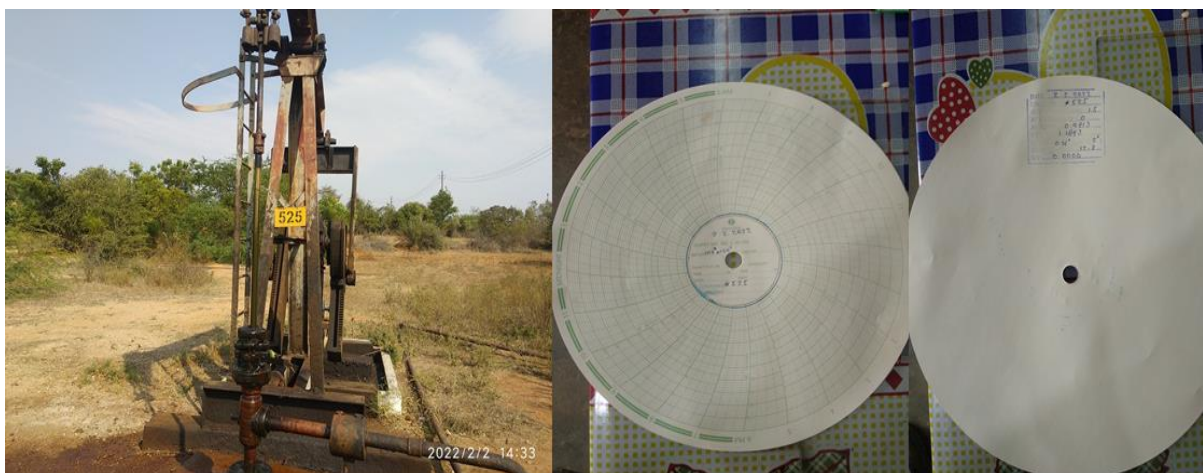
**Location** : Well – 567  
**Measurement** : Gas Volume Measurement by using Orifice Meter  
**Date** : 03 January 2022  
**Gas Volume** : 0 MMCFD

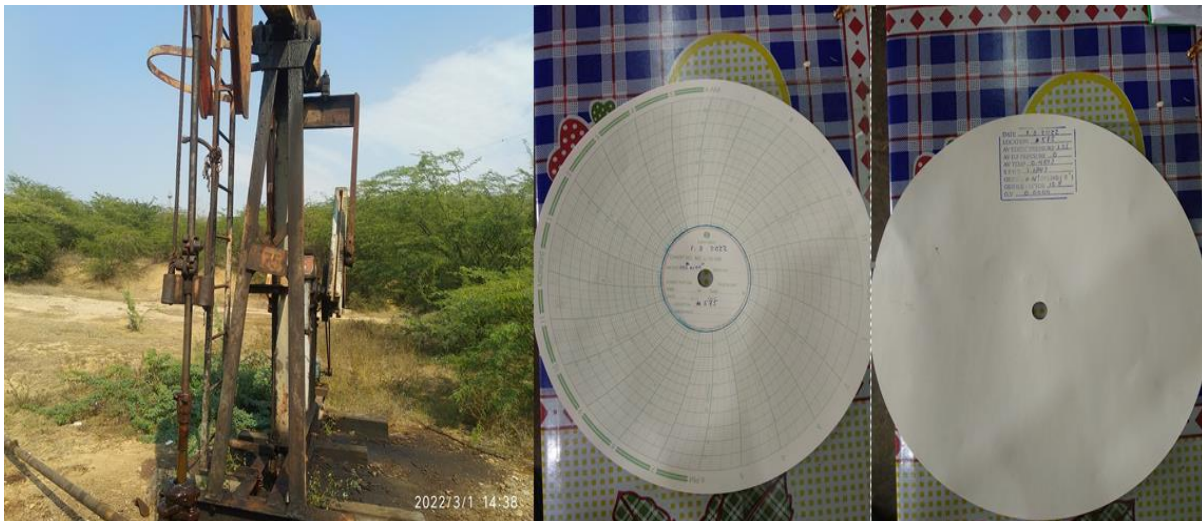
**Location** : Well – 575  
**Measurement** : Gas Volume Measurement by using Orifice Meter  
**Date** : 03 January 2022  
**Gas Volume** : 0 MMCFD

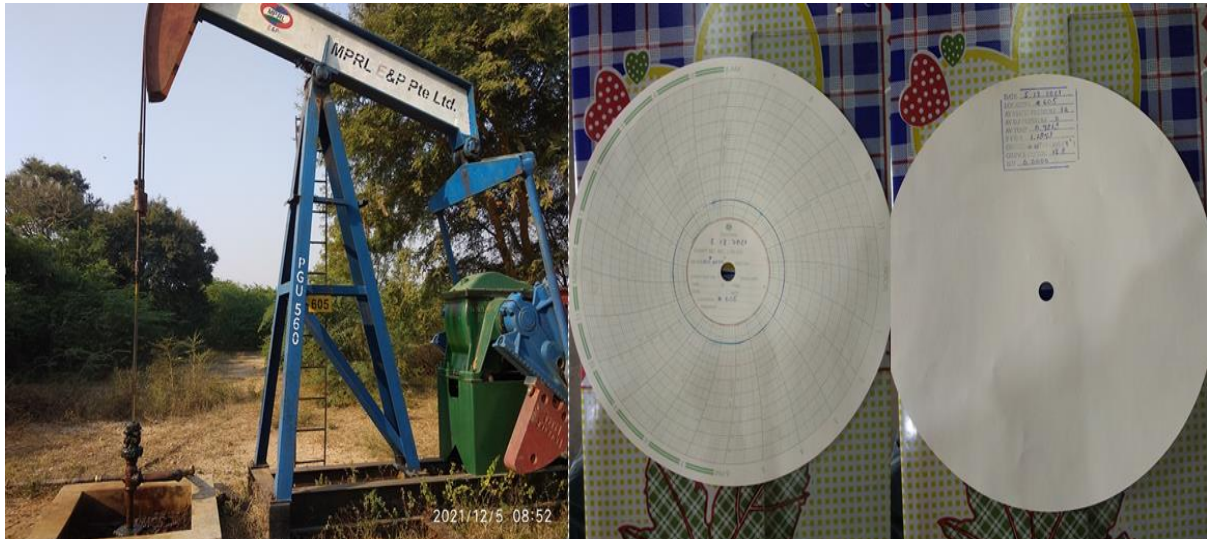
**Location** : Well – 605  
**Measurement** : Gas Volume Measurement by using Orifice Meter  
**Date** : 05 December 2021  
**Gas Volume** : 0 MMCFD

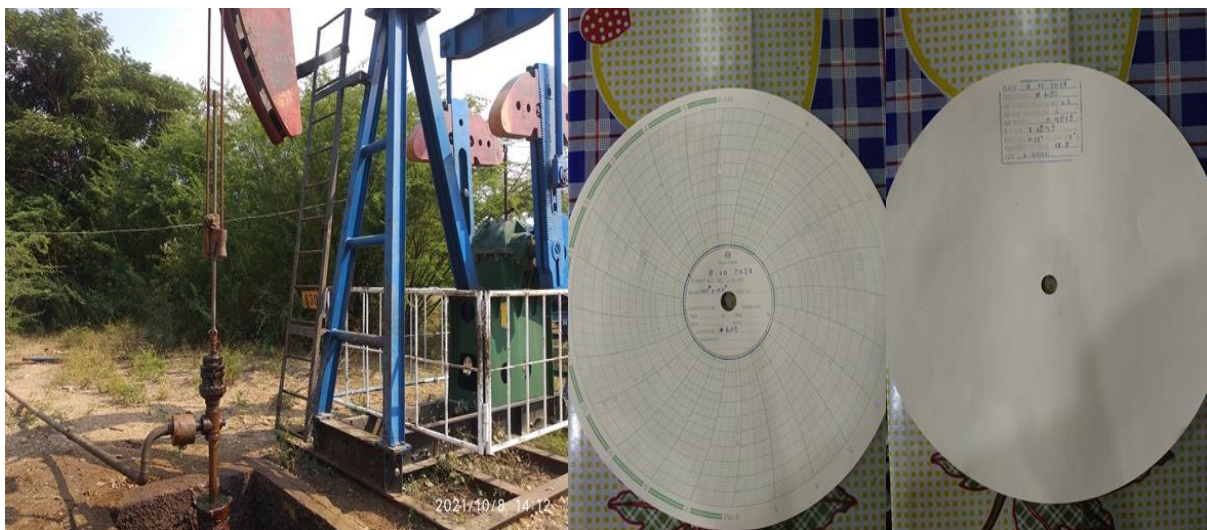
**Location** : Well – 630  
**Measurement** : Gas Volume Measurement by using Orifice Meter  
**Date** : 08 October 2021  
**Gas Volume** : 0 MMCFD

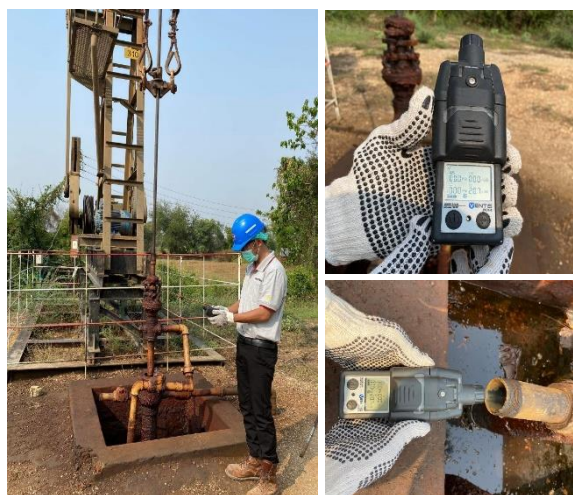
**Figure 34: Monitoring at M-310 near MaeBaeKone Village**

This is monitored with the In-house portable gas detector (VENTIS MX4 Gas Detector) which have been calibrated equipment as attached in Annex – 2 Equipment Calibration Certificate and Four (4) parameters able to monitor with this equipment. As the monitoring result, there is no detectable of the H<sub>2</sub>S parameters and the result of each wells are listed as above table 15.

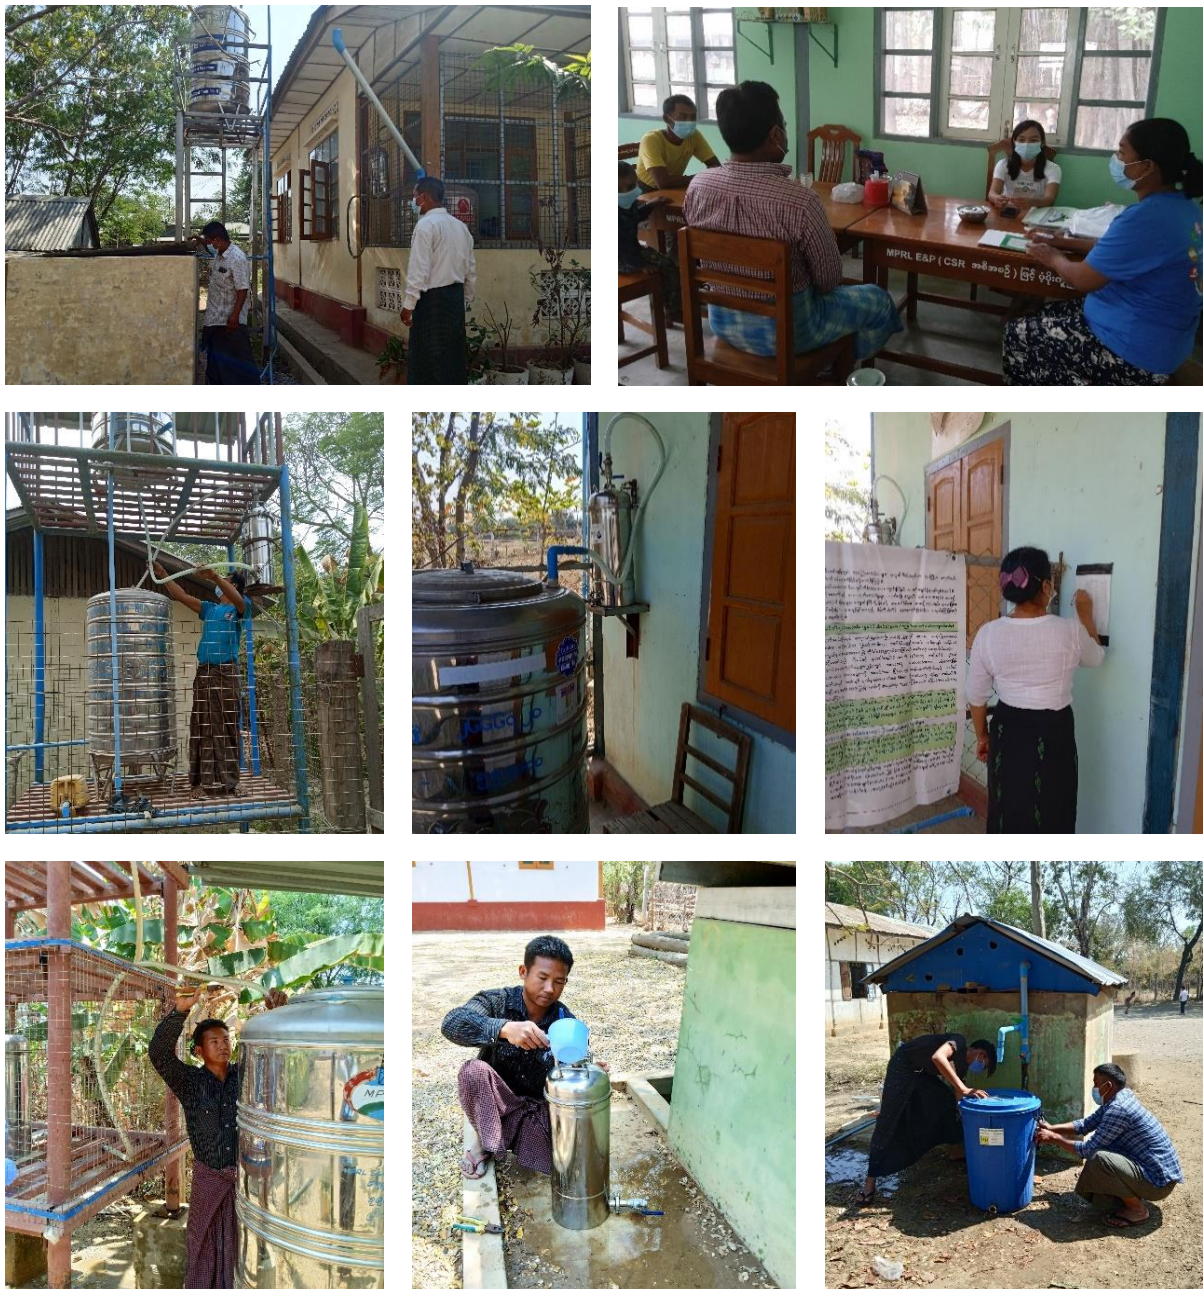
**Figure 64: Monitoring Maintenance on Water Purifiers and Tanks in Schools and Villages**

With all-inclusive growth and sustainable development, the CSR Program recognizes the importance of careful maintenance on community infrastructure provided by the company. In February 2022, the CSR Team performed maintenance check and provided technical assistance on water filtration units, provided by the CSR Program as part of community infrastructure development projects around Mann Field Communities. The Team also organized meeting with School and Village Development Committee members and discussed action plans for long-term maintenance on community infrastructure projects.
