# Environmental Monitoring Report

for Redevelopment and  
Enhanced Oil Recovery (EOR)

Programme October 2022 – March 2023

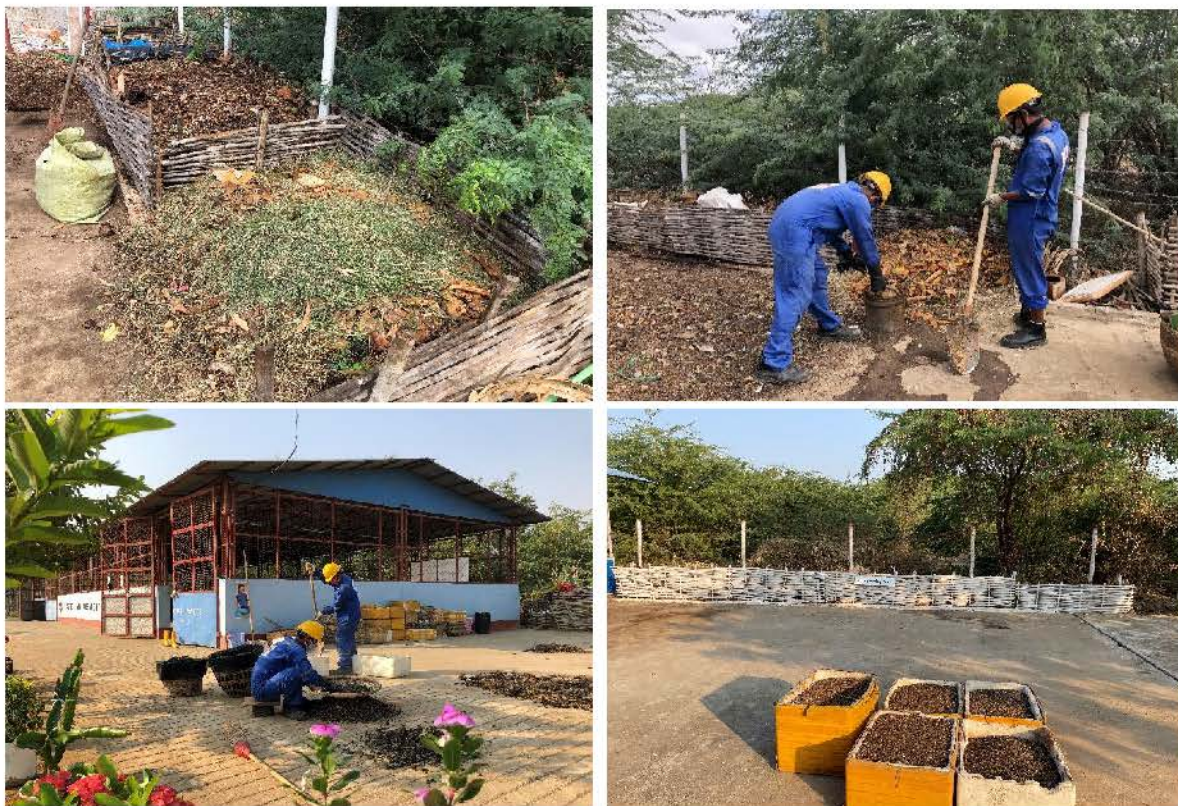
Figure 4: Composting at WMC

Based on our self-monitoring records spanning six months from October 2022 to March 2023, the composting process has yielded approximately 1265 kg of compost. While the process is notably rapid during summer, the composting bacteria do not function optimally under neutral conditions in the rainy season.

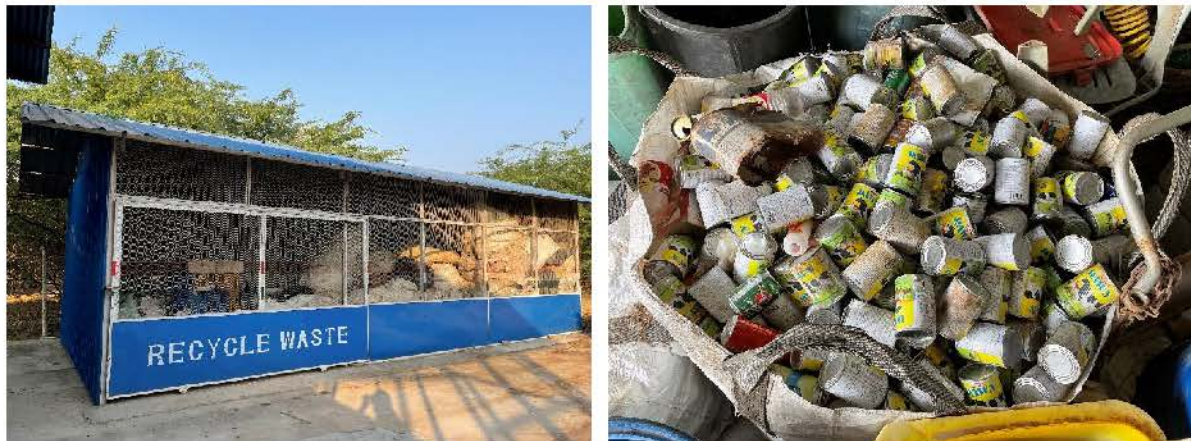
*Figure 5: Recycle Waste Storage at WMC*

The details of the type and quantity of recycle wastes have been registered using the 'Waste Register' form.

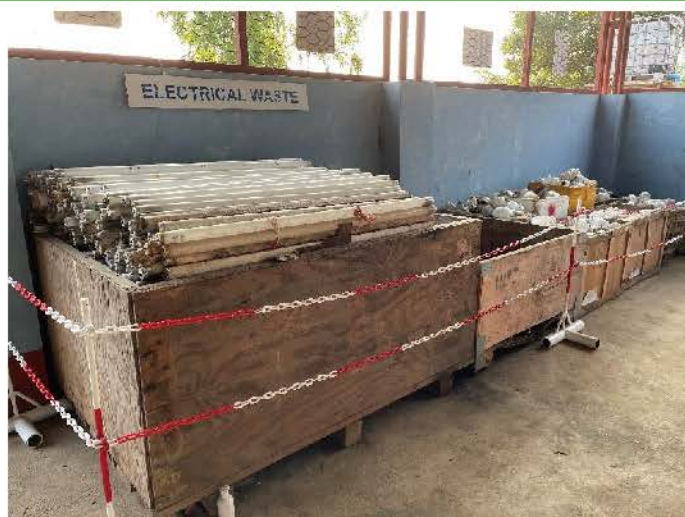
**Figure 7: Hazardous Waste Storage Area at WMC**

A total of 20,495 kg of hazardous waste is collected from all work-related areas and is properly stored at the Waste Management Compound. The volume of hazardous waste collected was high in March 2023, with most of it being dry sludge from GOCSs. The dry sludge/ produced sand is temporarily stored at the Waste Management Compound, while the wet sludge is stored at the Sludge Management Compound. Sludge composition tests for both wet sludge and dry sludge/produced sand were conducted at Golden DOWA Ecosystem in 2022, and arrangements for the disposal of E-waste are being made for the first step in 2023.

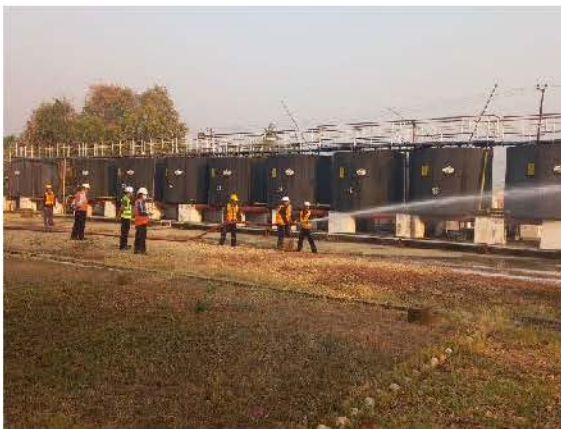
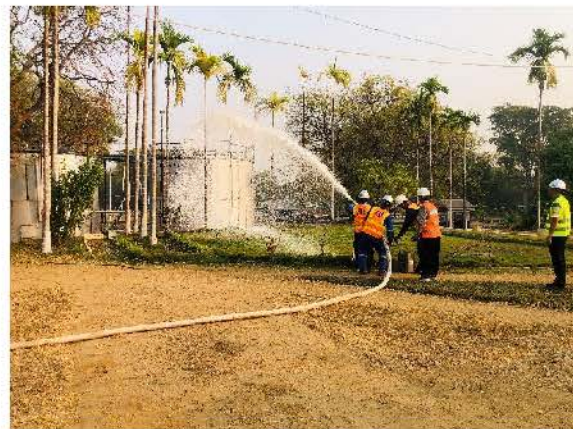
**Figure 10: Fire Drill at GOCS-1 and GOCS-2**

The aim to acquaint all employees with fire outbreak scenarios and enhance ties with local authorities was achieved through fire drills conducted at GOCS-2 on 24 February 2023 and GOCS-1 on 04 March 2023. The drills aimed to enable employees to proficiently execute the designated fire emergency response procedure.

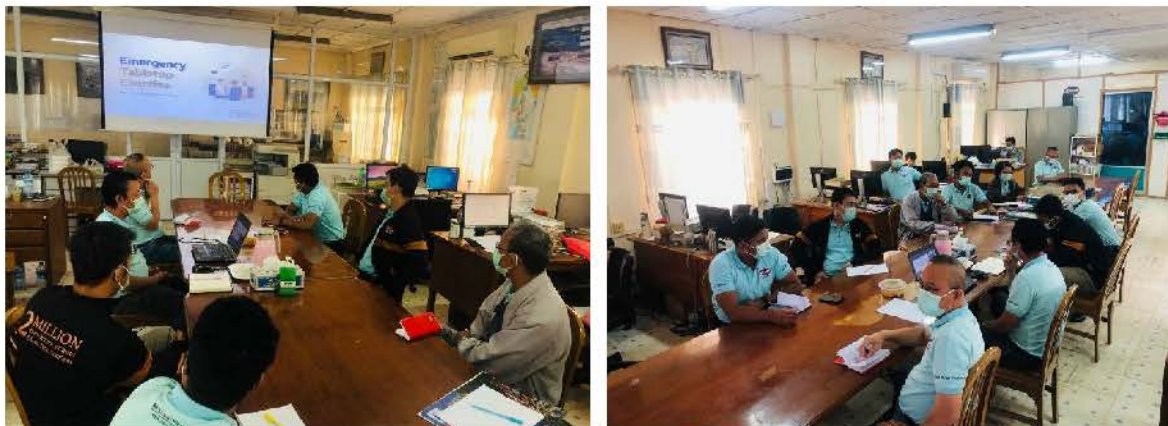
*Figure 11: Spill Drill (table-top exercise) on 05 March 2023*

A spill drill (table-top exercise) was conducted on March 5, 2023, at the MPRL E&P Base Camp. The exercise involved a discussion of the spill response team's roles and responsibilities, as well as the usage of spill kits and tools, and the need to inform authorized personnel immediately.

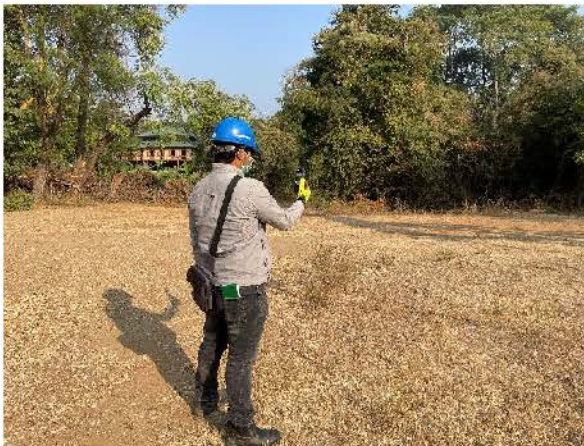
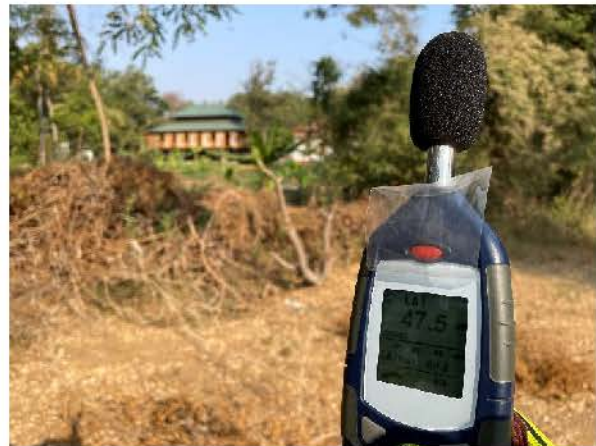
*Figure 21: Noise monitoring near community areas*

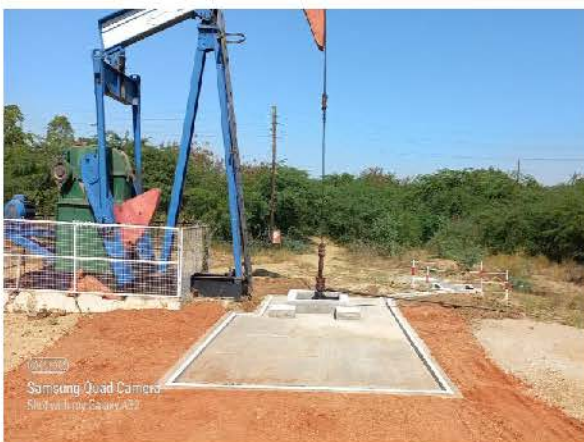
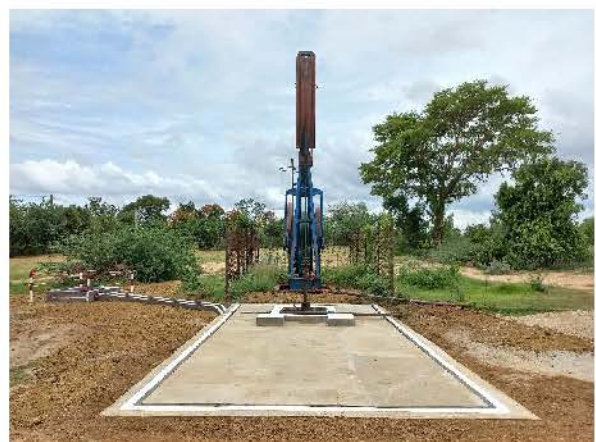
*Figure 22: Concrete pad and additional cellar at M-16 and M-80*

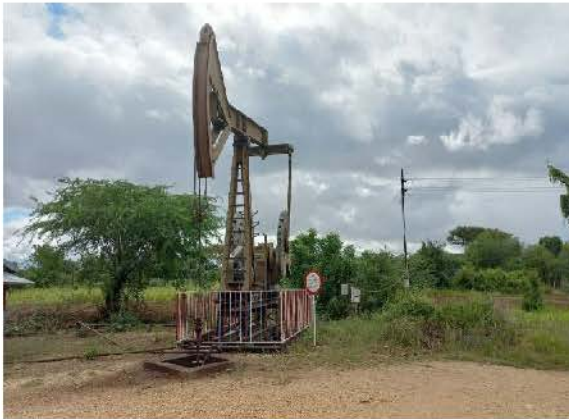
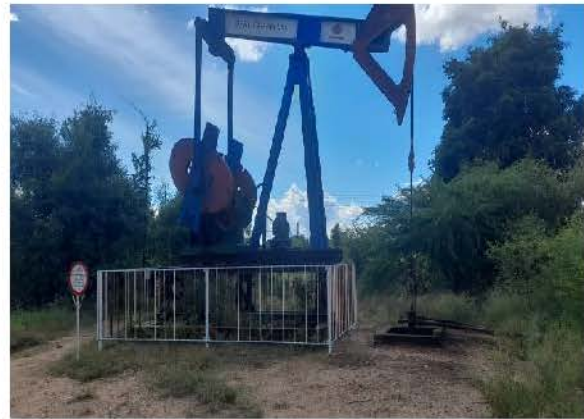
*Figure 23: Pumping Unit Fencing at Mann Field*

**Improvement of Pumping Unit** – pumping units will be / have been repaired to reduce the likelihood of spills in the surrounding areas.

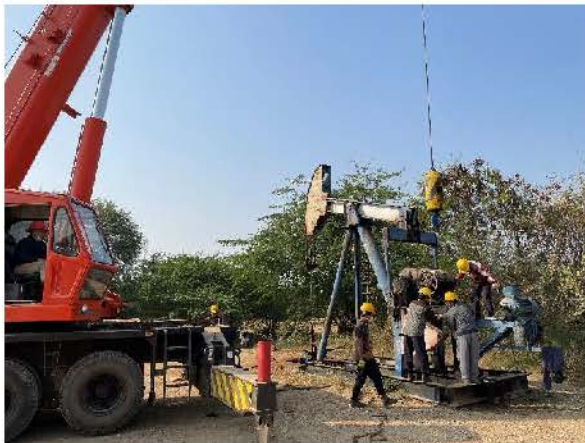
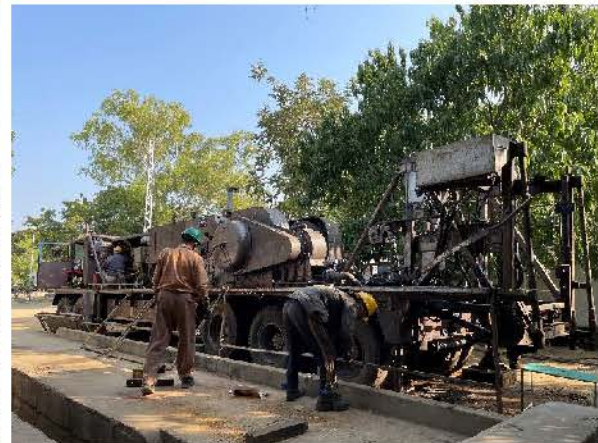
*Figure 24: Regular maintenance of machines*

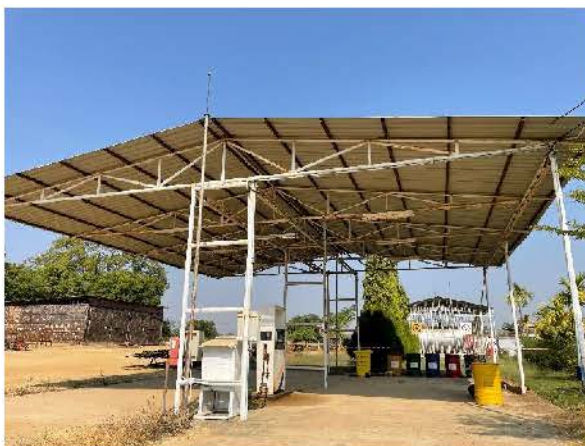
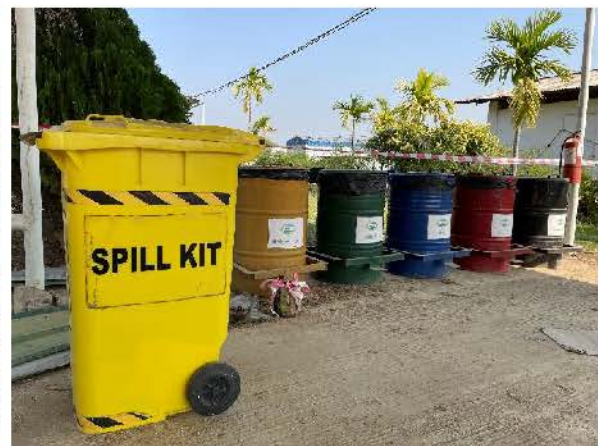
*Figure 25: Fueling station at Mann Oil Field*

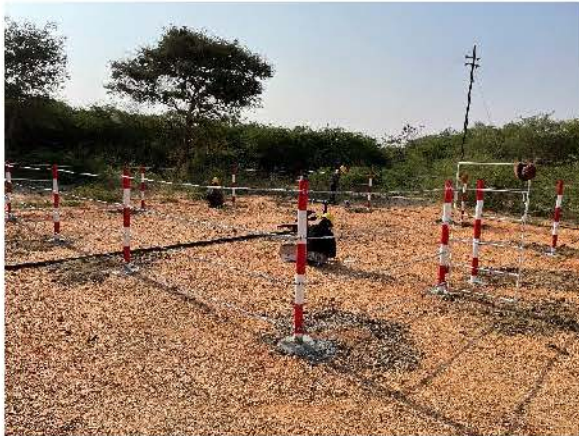
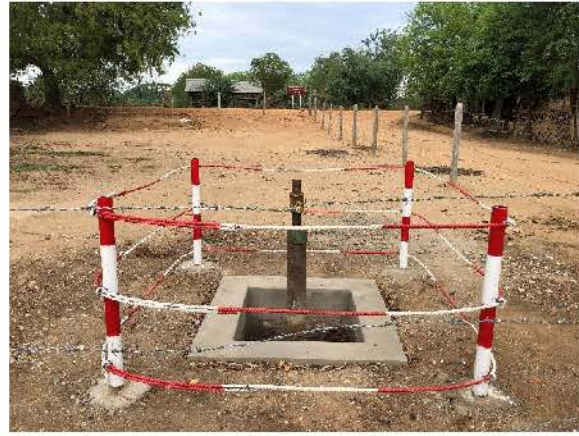
Figure 26: Shut-in wells M-106 and M-184

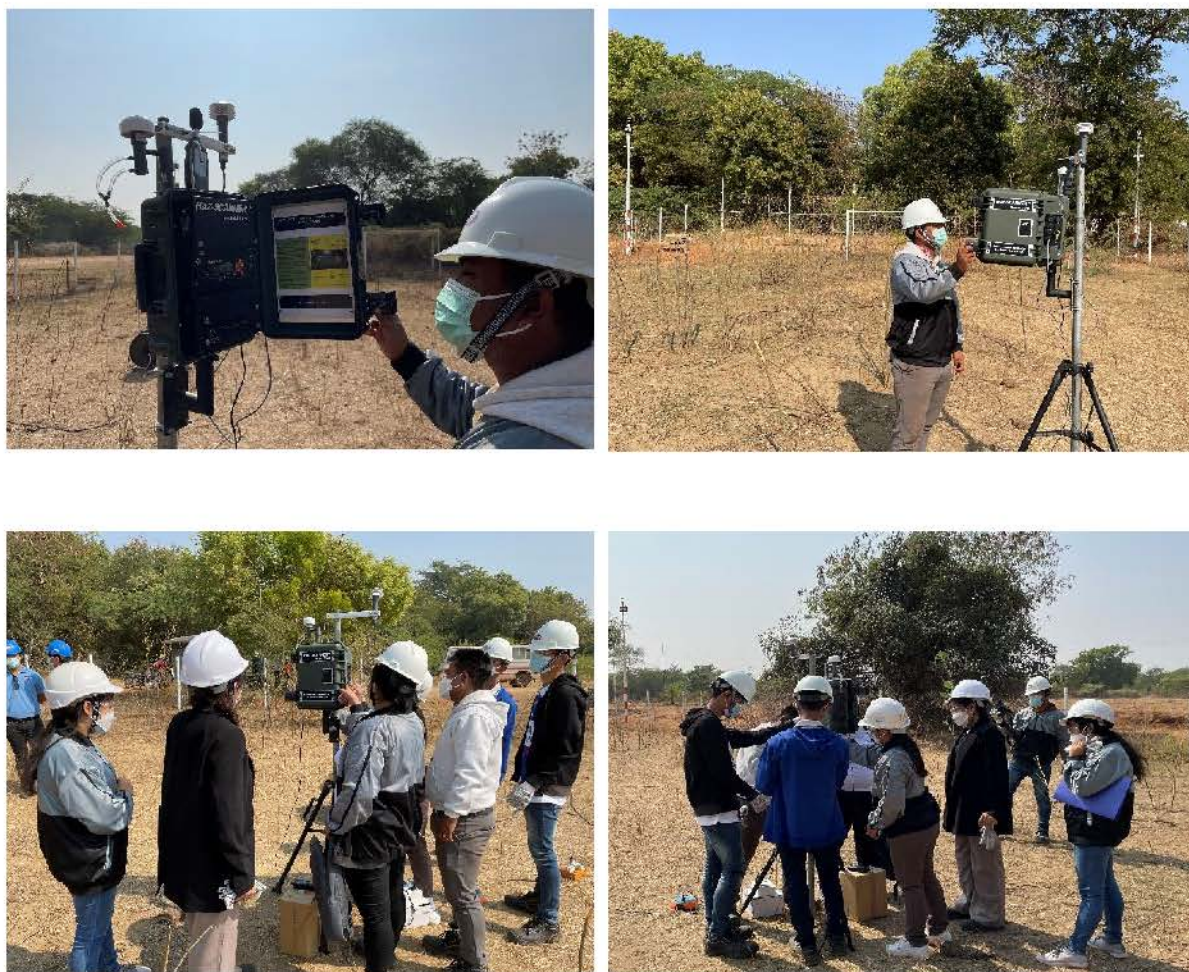
*Figure 30: Air & Noise Quality Monitoring at Z3AQN by the regional ECD (Magway)*

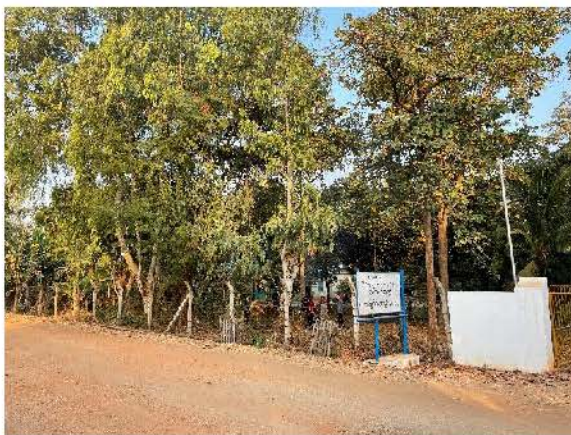
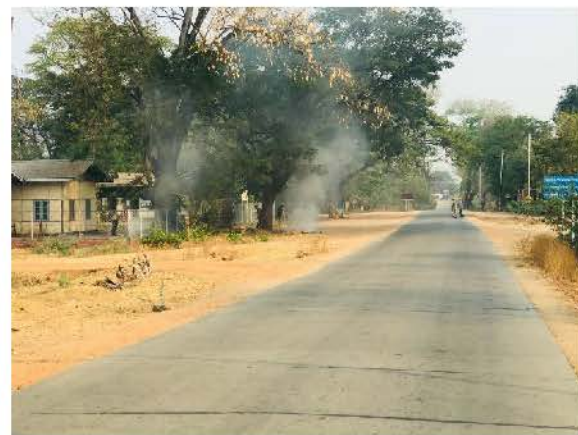
*Figure 31: Smokes and open burning near Z3AQN*

The Air Quality monitoring results indicate that all the parameters are within NEQEG standards, except for the PM<sub>10</sub> value. The increase in PM<sub>10</sub> value could be due to various factors, including industrial activities, transportation emissions (especially from diesel vehicles) along G-20 main road near Z3AQN, natural sources such as dust, weather conditions (such as wind speed and direction, temperature and humidity), and human activities such as burning of solid fuels for cooking and open burning of trash and leaves. We observed open burning near Z3AQN during the monitoring period and have included a photo as evidence.

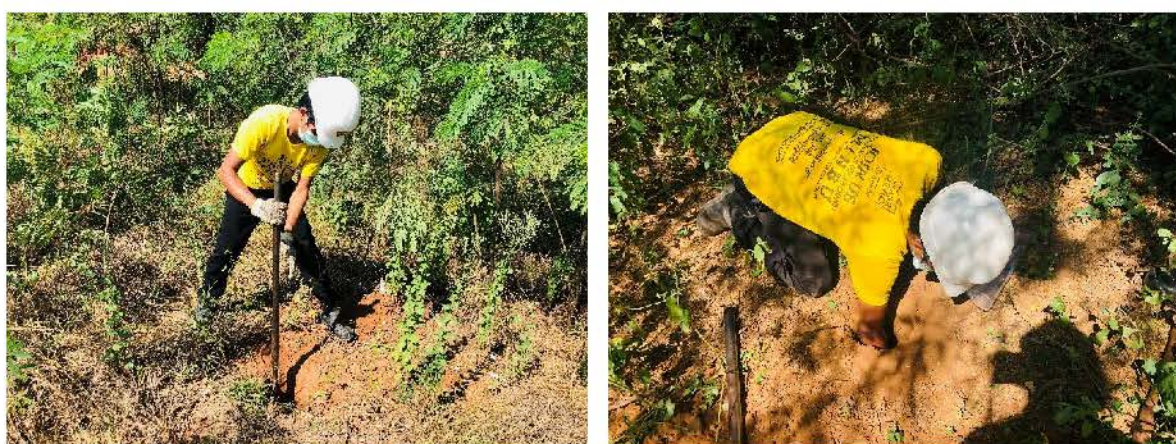
**Figure 33: Soil Quality Monitoring at Z3S1 and Z3S2**

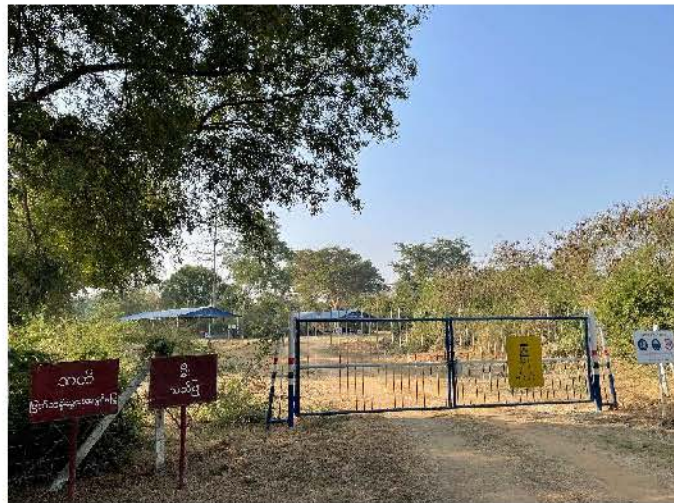
*Figure 34: Sludge Management Compound (SMC)*

Dried sludge, weighing approximately 104 tons (estimated weight), is currently being stored temporarily at the Waste Management Compound. We have plans to construct a temporary storage area in the Sludge management compound. Currently, all the sludge is being stored properly in concrete pits.

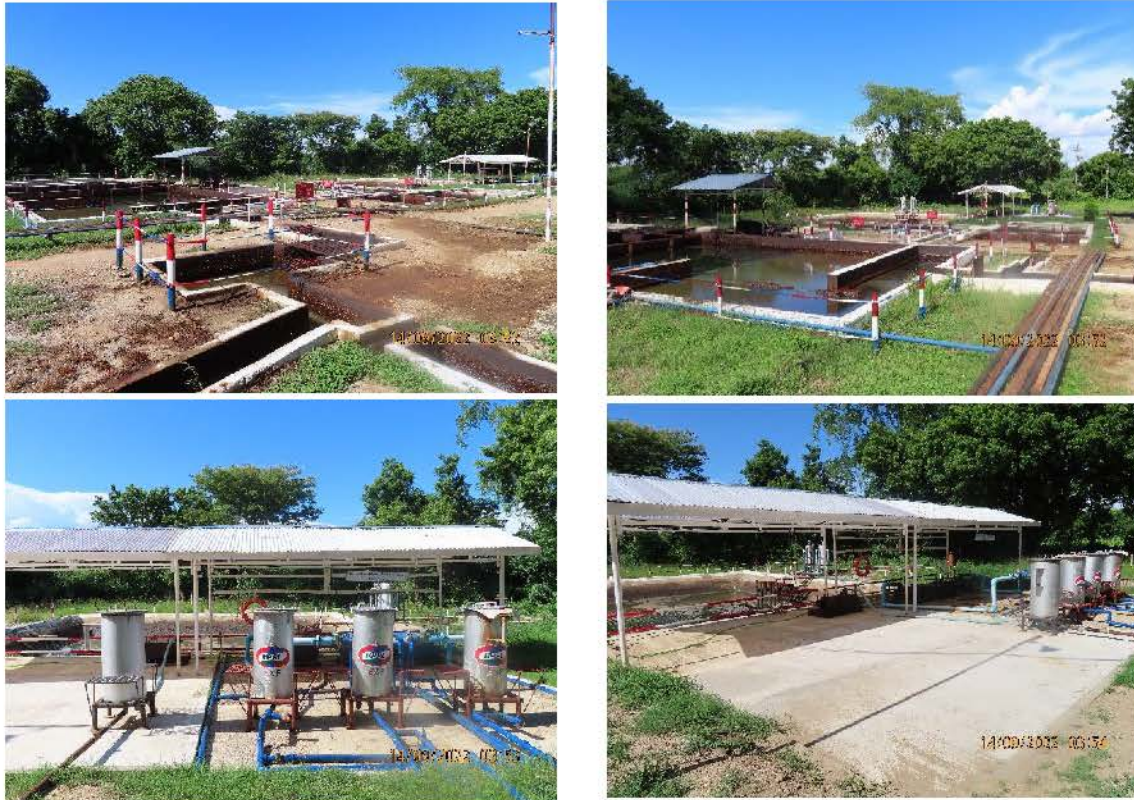
*Figure 35: Produced Water Management at GOCS-2*

MPRL E&P is undertaking to inject all produced water (100%) into the shut-in wells by using 8 units of injection pumps to meet guideline levels in NEQEG for Onshore Oil and Gas Development.

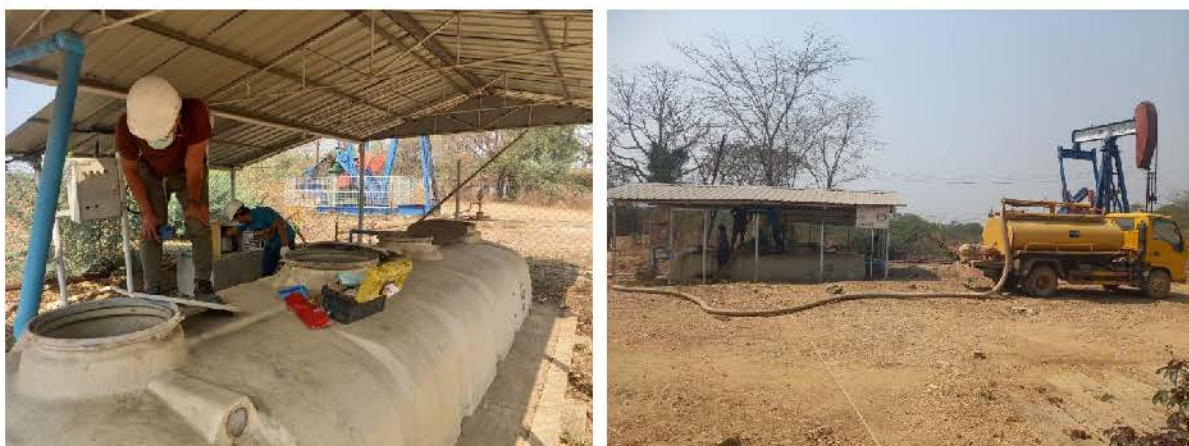
*Figure 39: Desludging and third-party regular maintenance of Bio-Filter*

Regular safety meetings and toolbox talks are held to raise awareness about water conservation, energy conservation, and water pollution among all crew members. Additionally, inspections are conducted to ensure that there are no leaks or wastage of water from pipelines and basins during routine camp inspections.

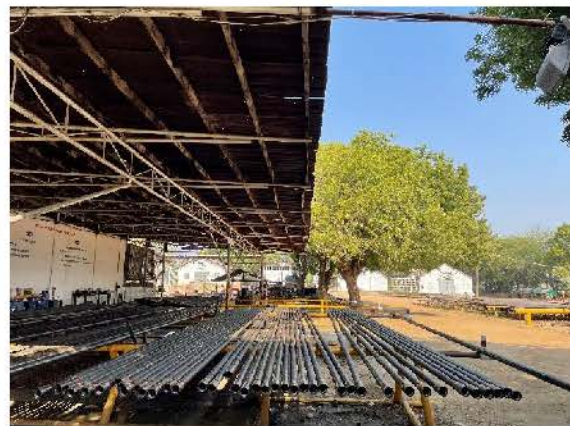
**Figure 40: Warehouse Tubular Section**

At the Mann field warehouse, the team previously conducted hydro tests on tubing in a designated pressure test area. However, the field team has since minimized water usage by implementing a recycling system that uses zero discharge recycled water for these tests.

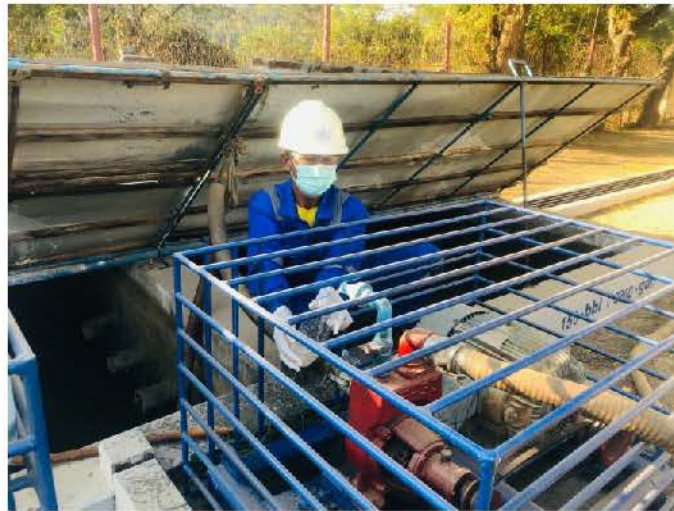
*Figure 41: Water Sample Collection at Warehouse Zero Discharge Tank*

The hydro-test water monitoring schedule was carried out between November 2022 and January 2023. The monitoring results revealed that all parameters complied with the NEQEG guidelines, except for the BOD<sub>5</sub> and TSS value. Hydro-testing involves using water to pressurize and verify the integrity of pipes, tanks, and other equipment. During this process, the water can absorb organic matter, oils, greases, and other contaminants. The high BOD<sub>5</sub> value in the hydro-test water is due to the accumulation of organic matter and chemicals during testing. The higher value of TSS may be many reasons such as residual debris in the system, corrosion and scale buildup, turbulence and high flow rates, and other environmental factors. To prevent contamination of natural water sources, we recycled the water using a zero-discharge tank instead of disposing of it after testing, and used appropriate filtration and settling systems.

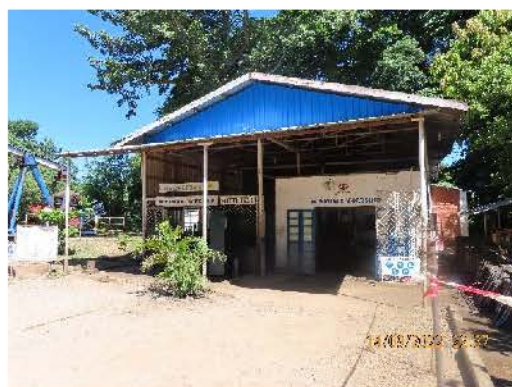
**Figure 42: Down-hole Workshop**

During the monitoring period from October 2022 to March 2023, two rounds of monitoring were conducted for the discharge of water from the equipment maintenance workshop (Down-hole Workshop) into the ZERO Discharge Tank. In November 2022 and January 2023, we monitored a total of thirty parameters, and all of them complied with the NEQEG, except for total coliform bacteria. The Down-hole workshop draws its raw water from Mann creek, which may be contaminated. Additionally, dry leaves, bird feces, and ripened fruits in the surrounding environment can introduce total coliform bacteria into the zero-discharge

tank. This may cause an accumulation effect due to storage conditions, which could explain why the total coliform count exceeded the limit.

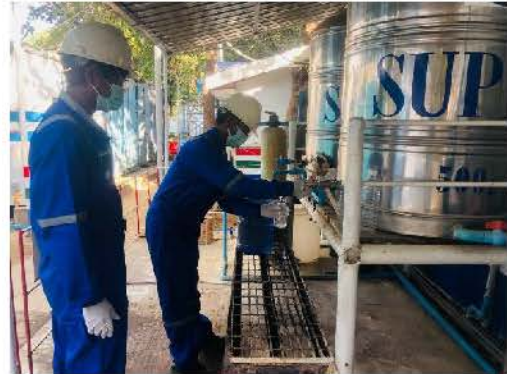
*Figure 44: Water sample collection at RO drinking water system*

access to safe drinking water is crucial for everyone's wellbeing, which is why a Reverse Osmosis (RO) drinking water system has been installed in the base camp. This system ensures that there is sufficient purified water available for staff members to use for drinking water and food preparation. To maintain the quality of water, the team conducts quarterly water quality monitoring, and the site doctor and HSE team perform hygiene inspections and audits according to the planned schedule. Regular service and maintenance are also scheduled and implemented to ensure that the RO system continues to function properly.

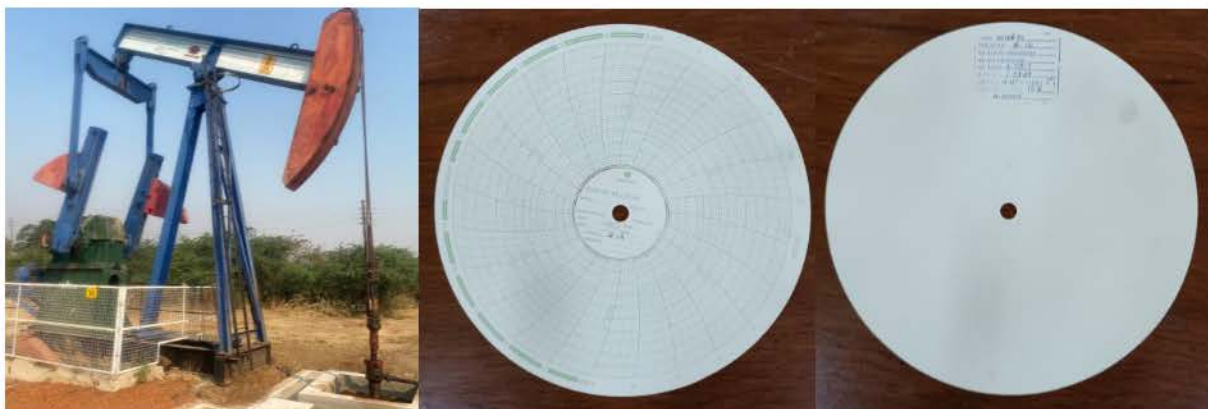
Location : Well – 59  
Measurement : Gas Volume Measurement by using Orifice Meter  
Date : 10 November 2022  
Gas Volume : 0 MMCFD

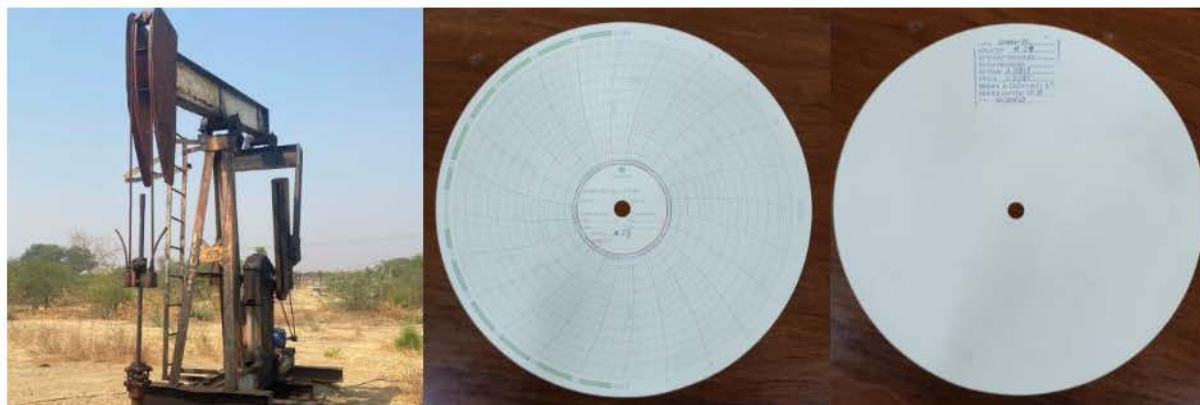
Location : Well – 47  
Measurement : Gas Volume Measurement by using Orifice Meter  
Date : 04 December 2022  
Gas Volume : 0 MMCFD

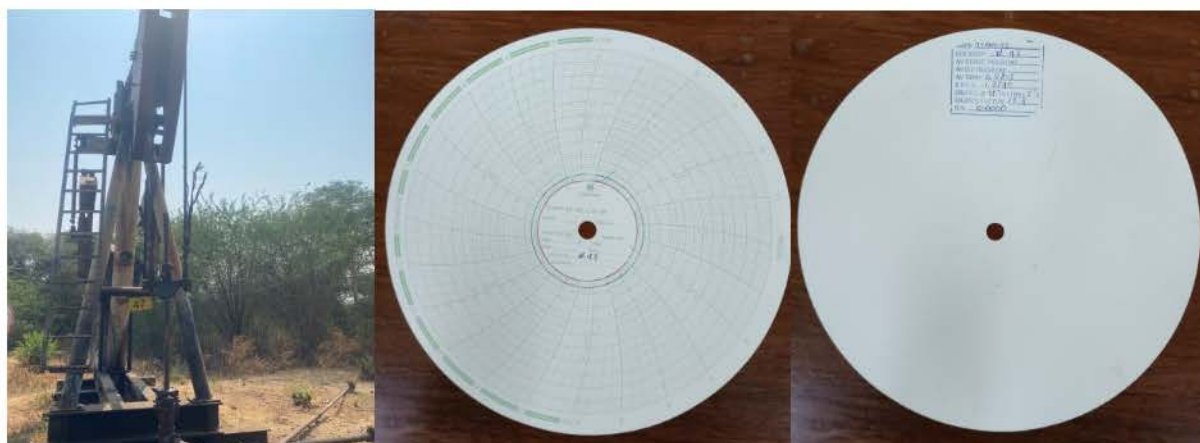
Location : Well – 289  
Measurement : Gas Volume Measurement by using Orifice Meter  
Date : 08 January 2023  
Gas Volume : 0 MMCFD

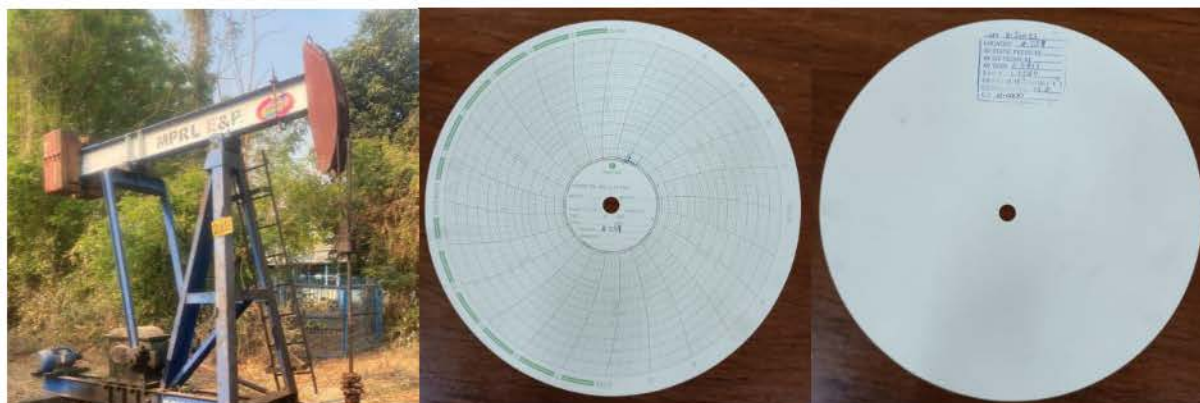
Location : Well – 18  
Measurement : Gas Volume Measurement by using Orifice Meter  
Date : 16 February 2023  
Gas Volume : 0 MMCFD

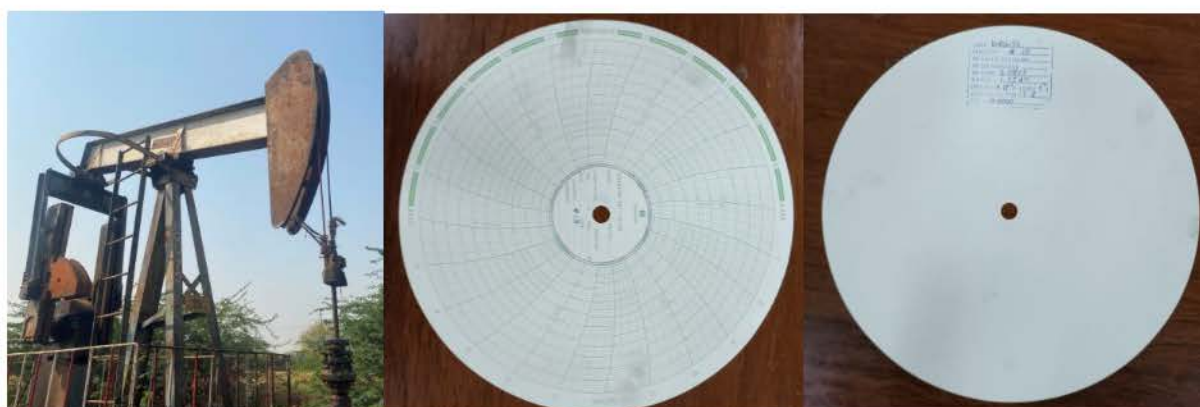
**Location** : Well – 40  
**Measurement** : Gas Volume Measurement by using Orifice Meter  
**Date** : 01 March 2023  
**Gas Volume** : 0 MMCFD

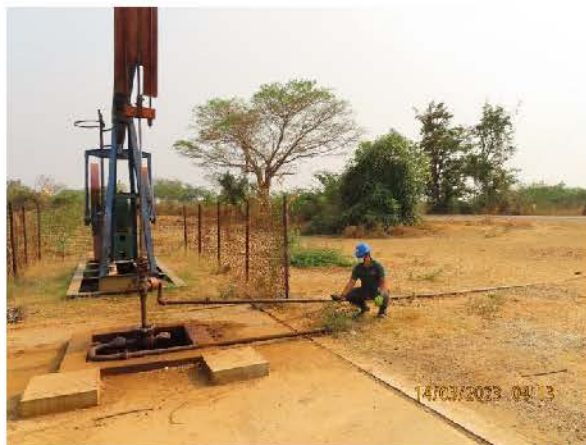
Figure 47: Monitoring at M-80

H<sub>2</sub>S levels are monitored using an in-house portable gas detector (VENTIS MX4 Gas Detector), which has been calibrated as shown in Annex – 2 Equipment Calibration Certificate. This equipment can monitor four (4) parameters. As a result of monitoring, no H<sub>2</sub>S was detected, and the results for each well are listed in the above Table 23.

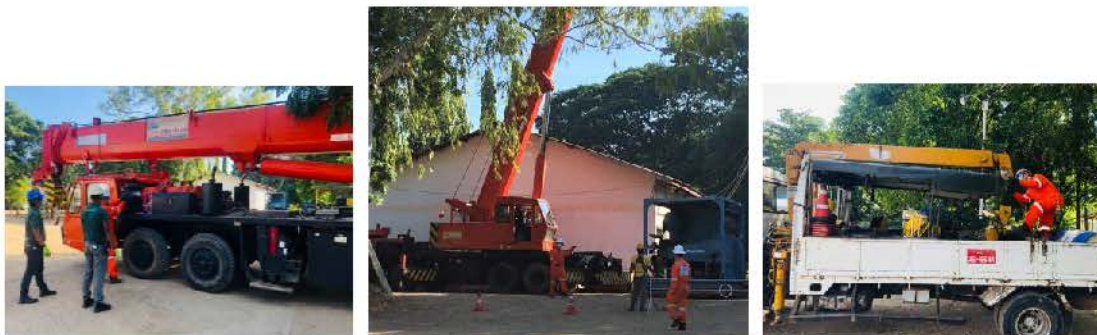
**Figure 54:** On 12 November 2022, third-party MIP inspector conducted “Crane Inspection & Recertification (3 Ton KS 303 & 55 Ton KATO)” in Mann Field

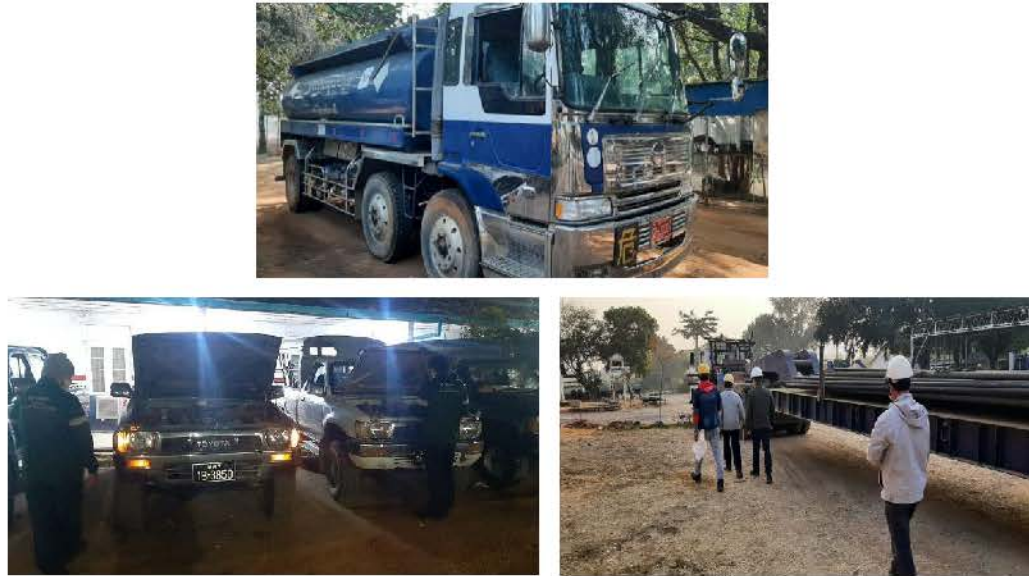
*Figure 55: Vehicle and Workshop Safety Inspection in Mann Field  
(17 January 2023 to 19 Jan 2023)*

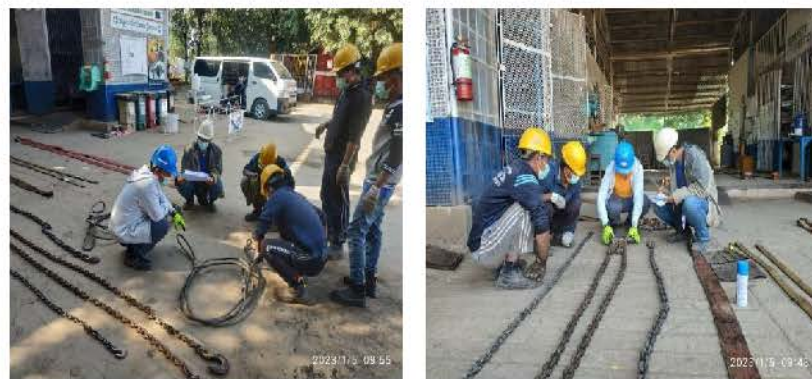
*Figure 56: Bi Annual Lifting Gear Inspection 5 January 2023*
