Environmental Monitoring Report

for Redevelopment and Enhanced Oil Recovery (EOR) Programme

October 2023 ~ March 2024

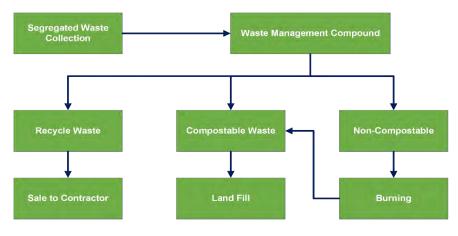
Figure 2: Waste Management Flowchart

Brief Waste Management Process is described as follows:

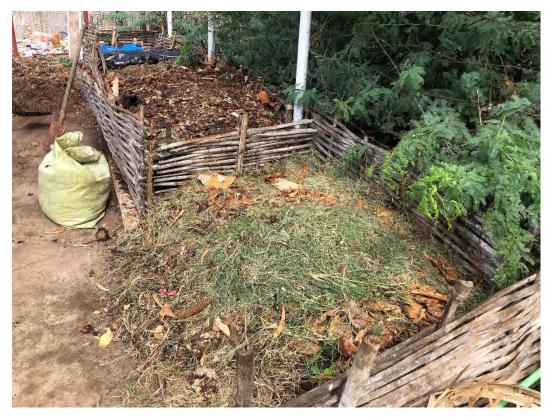
Figure 4: Composting of food waste and garden waste at WMC

Based on our self-monitoring records spanning six months from October 2023 to March 2024, the composting process has yielded approximately 1435 kg. of compost. While the process is notably rapid during summer, the composting bacteria do not function optimally under neutral conditions in the rainy season.

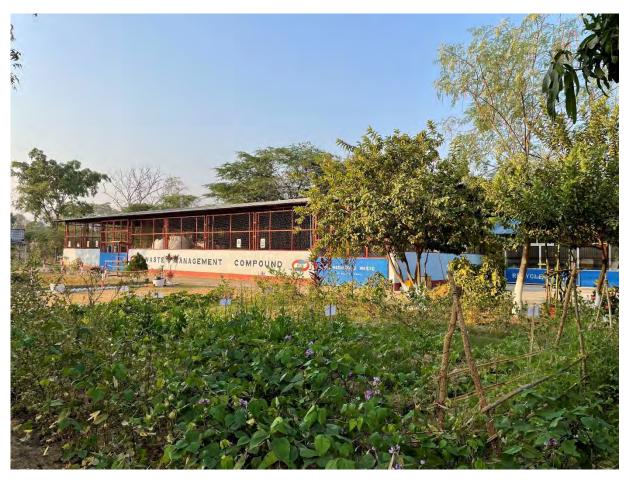
Figure 6: Waste Management Compound (WMC)

General Waste Storage in WMC

After being re-sorted, packed and stored in the recycle waste storage area, the recycle materials are disposed of by an authorized third party.

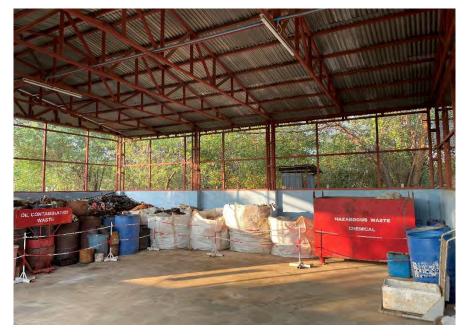
Figure 7: Oil Contaminated Waste Stored at WMC

From October 2023 to March 2024, a total of 10,520 kg. of hazardous waste is collected from all work-related areas and is properly stored at the Waste Management Compound. The volume of hazardous waste collected was high in January 2024, with most of it being dry sludge from GOCSs. The dry sludge/ produced sand is temporarily stored at the Waste Management Compound, while the wet sludge is stored at the Sludge Management Compound.

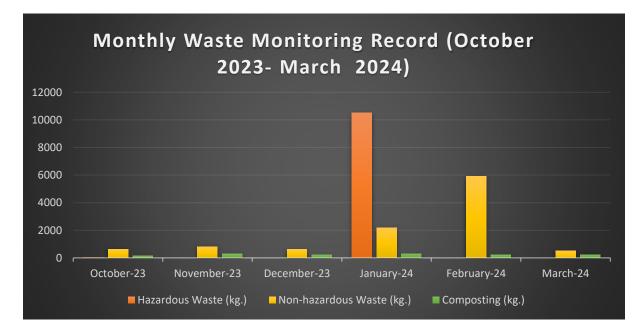
Figure 8: Monthly Waste Monitoring Records from Oct 2023 - Mar 2024

Month	Hazardous Waste (kg.)	Non-hazardous Waste (kg.)	Composting (kg.)
October 2023	20	646	160
November 2023	0	811	290
December 2023	0	636	220
January 2024	10,500	2198	310
February 2024	0	5,938	215
March 2024	0	500	240
Total	10,520	10,729	1435

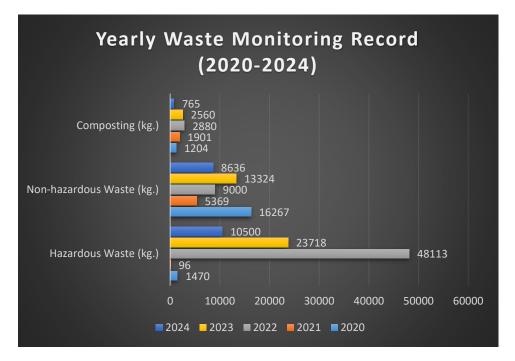
Figure 9: Yearly Waste Monitoring Record (2020 - 2024)

Year	Hazardous Waste (kg.)	Non-hazardous Waste (kg.)	Composting (kg.)
2020	1,470	16,267	1,204
2021	96	5,369	1,901
2022	48,113	9,000	2,880
2023	23,718	13,324	2,560
2024	10,500	8,636	765

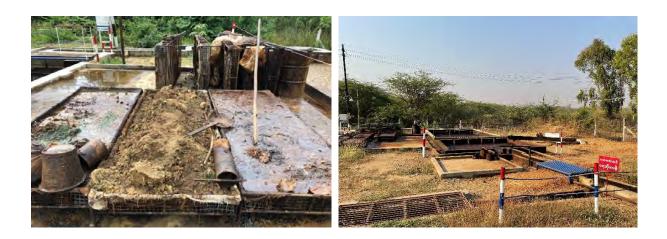
Figure 20: Drying Sludge at GOCSs

Currently, all the collected wet sludge is being stored properly in two concrete pits to ensure compliance with the NEQEG guideline levels for Onshore Oil and Gas Development. Any hazardous waste will be disposed of according to the commitments made in the ECC.

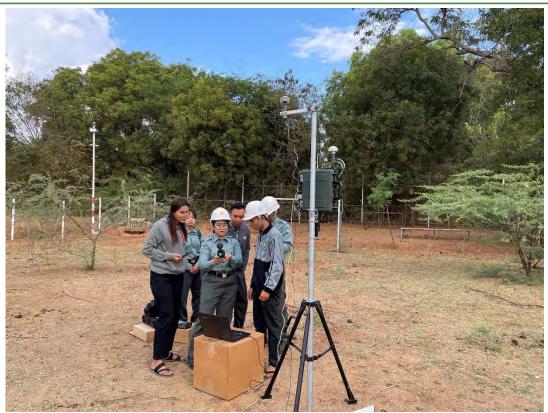
Figure 33: Air and Noise Quality Monitoring at Z3AQN

By Table 12, the Air Quality monitoring results at both the Z3AQN and Z4AQN during January 2024 indicate that all the parameters are within NEQEG standards except for the PM10 value at Z3AQN and Z4AQN. The reasons for higher value of PM10 may be many reasons such as leaves and wood burning practice in surrounding, weather conditions, transportation, vehicle usage. The monitoring results are attached and shown in Appendix A.

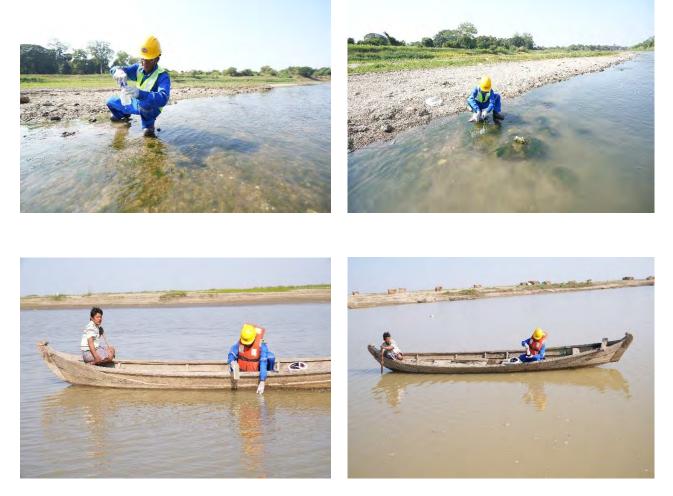
Figure 38: Surface Water Quality Monitoring at Z3SW1, Z3SW2, Z4SW1, and Z4SW2

As per the monitoring results of surface water in January 2024 as shown in Table 19, total phosphorous value is higher in lab result and it may be many reasons such as agricultural runoff, wastewater, soil erosion, septic systems, aquatic plant decomposition, industrial discharges, and natural sources, etc.

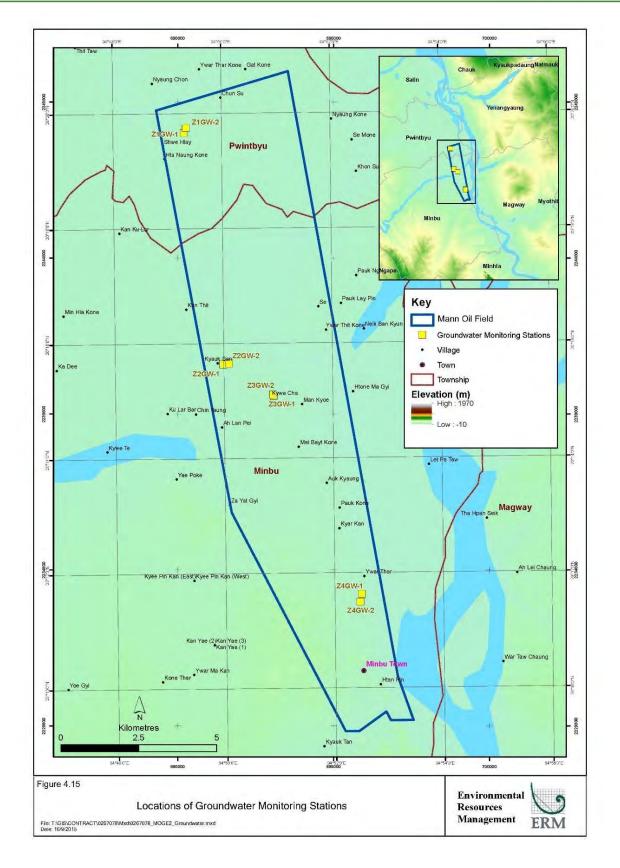
Figure 39: Groundwater Quality Monitoring Locations

The groundwater quality monitoring was conducted at three existing residential wells (dug wells and drilled/ tube wells) in the Project Area. The sampling locations are presented in the Table 21 and its surrounding conditions are expressed in the Figure 42.

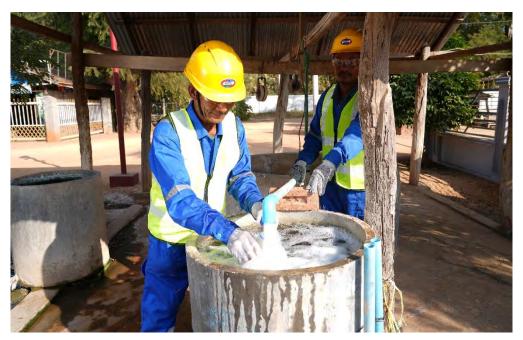
Figure 40: Groundwater Quality Monitoring at Z3GW1, Z3GW2, and Z4GW2

The results of groundwater quality monitoring are summarized in Table 22. As per the results, the BOD₅ value is higher than the WHO Drinking Water Quality Standard at all locations but other parameters are complied with the standards and we found that BOD_5 value was over the standard at time of the baseline water sample monitoring for EIA report in 2015.

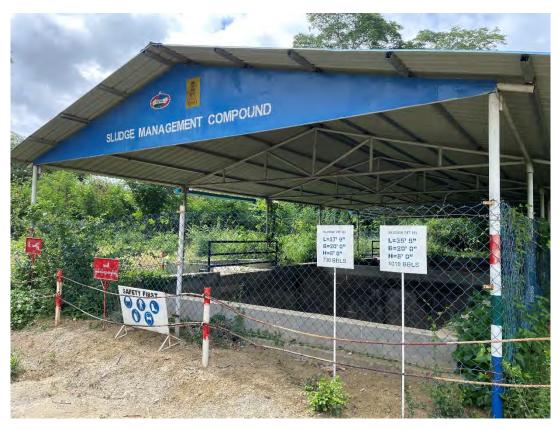
Figure 41: Sludge Management Compound (SMC)

Dried sludge, weighing approximately 123 tons (estimated weight), is currently being stored temporarily at the Waste Management Compound and at the Sludge Management Compound (extended dried sludge storage shed).

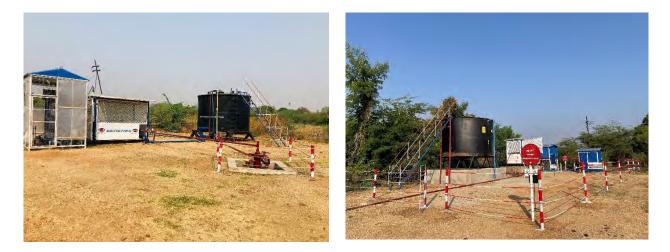
Figure 42: Produced Water Injection into Shut-in Wells

MPRL E&P is undertaking to inject all produced water (100%) into the shut-in wells by using 8 units of injection pumps to meet guideline levels in NEQEG for Onshore Oil and Gas Development.

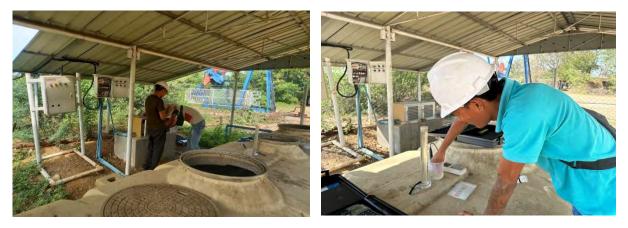
Figure 45: Regular Maintenance of Bio-filter by Third-party

Regular safety meetings and toolbox talks are held to raise awareness about water conservation, energy conservation, and water pollution among all crew members. Additionally, inspections are conducted to ensure that there are no leaks or wastage of water from pipelines and basins during routine camp inspections.

During the month of January 2024, we collected water samples from the bio-filter treated system and sent them to ALARM and DOWA lab for testing. We monitored a total of eight parameters and discovered that the total coliform value is exceeded the NEQEG guideline. Regular maintenance is crucial to ensuring proper functioning of the bio-filter system. Failure to maintain the system properly can result in clogging or damage, leading to a decrease in treatment efficiency and an increase in total coliform bacteria, the bio-filter's media fails to remove contaminants, including coliform bacteria, the system's ability to effectively treat sewage is compromised. Consequently, we contracted Wa Min, a third-party company, to provide annual bio-filtration unit service.

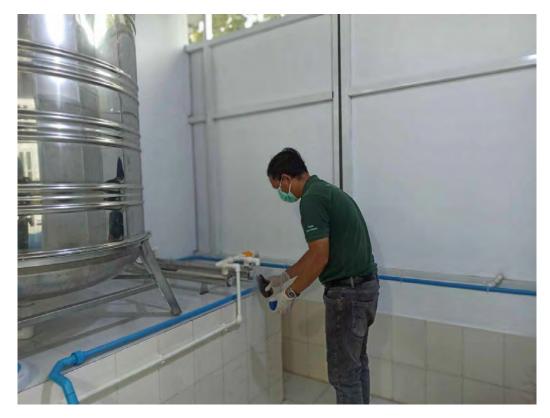
Figure 50: Collection of Drinking Water Sample from RO Drinking Water System

Access to safe drinking water is crucial for everyone's wellbeing, which is why a Reverse Osmosis (RO) drinking water system has been installed in the base camp. This system ensures that there is sufficient purified water available for staff members to use for drinking water and food preparation. To maintain the quality of water, the team conducts quarterly water quality monitoring, and the site doctor and HSE team perform hygiene inspections and audits according to the planned schedule. Regular service and maintenance are also scheduled and implemented to ensure that the RO system continues to function properly.

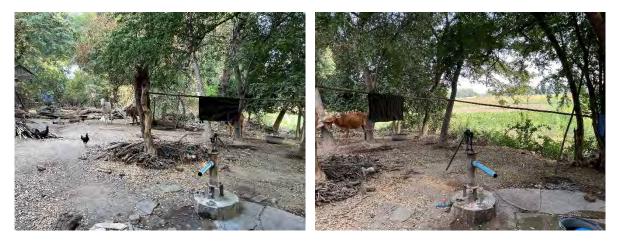
Figure 51: Tube Well of Ko Win Maung

In January 2024, MPRL E&P conducted groundwater quality monitoring near well 132 (Ko Win Maung) and found that all parameters were within the Drinking Water Quality Standard (2019), except total coliforms, manganese, and sulfate. The presence of bacteria in tube well indicates microbial pollution mainly due to septic systems, farming of cows near the source of water. The high sulfate levels may be due to geological factors, human activities, and microbial activity. The owner of the tube-well did not use the water for drinking purposes, but instead used it for bathing, watering plants and washing.

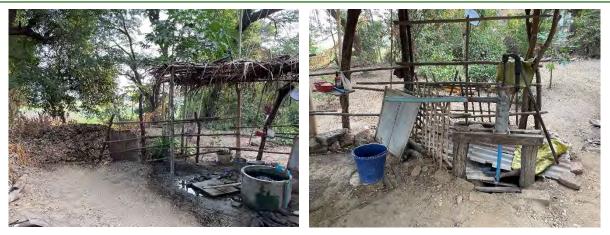
Figure 52: Tube Well of Ma Nyein

At the Ma Nyein Well, all the results were shown to be under the Drinking Water Quality Standard (2019), except for total dissolved solids and sulfate. The manganese and lead value may be high due many reasons such as geological sources, industrial pollution, agricultural runoff, corrosion of plumbing, poor structures, environmental factors, etc. The high sulfate levels may be due to geological factors, human activities, and microbial activity. The tube well is approximately 20 feet deep and is mainly used for watering plants, washing, and bathing purposes.

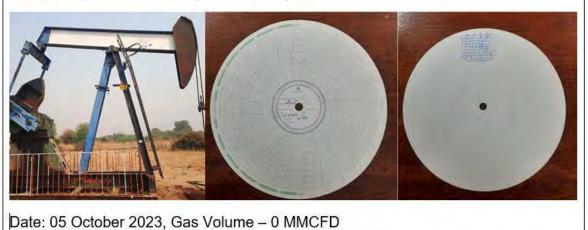
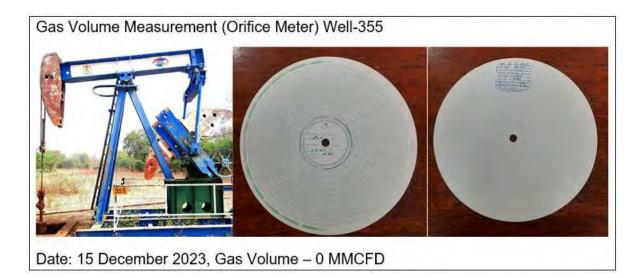
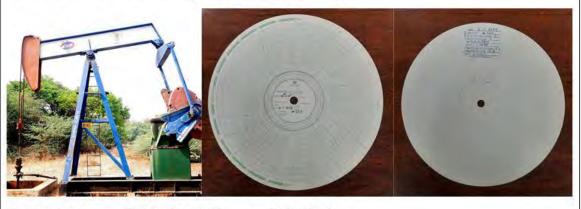
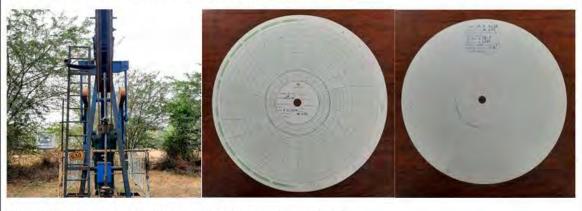
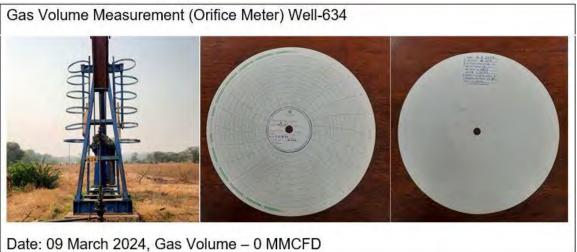
Figure 53: Gas-Vented Wells and Vented Gas Volume Measurement Record

In accordance with the gas venting monitoring program, MPRL E&P's technical team utilizes an Echo Meter to monitor and measure gas volume. If the recorded gas volume substantially exceeds the previous measurement, an orifice meter is employed to validate the volume within a 24-hour timeframe. Once the gas volume is confirmed to be sufficient, the team connects to the gas line and channels the collected gas to the existing facility supplying gas lines to the LPG plant. Continuous monitoring indicates a reduction in well counts and vent gas volume. The team has effectively minimized the venting gas volume, achieving successful mitigation. See Figure 53.

Date: 10 November 2023, Gas Volume - 0 MMCFD

Date: 02 January 2024, Gas Volume – 0 MMCFD

Date: 07 February 2024, Gas Volume – 0 MMCFD

Date: 09 March 2024, Gas Volume – 0 MMCPD

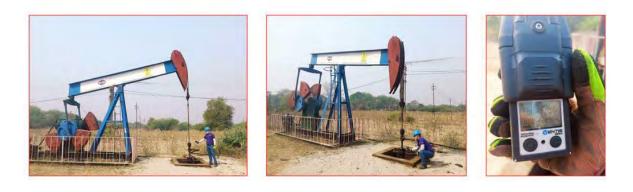
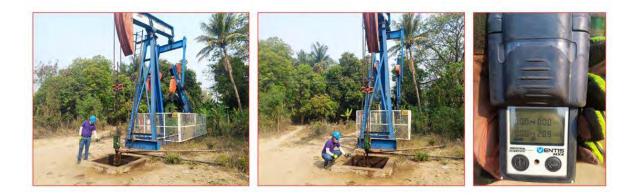
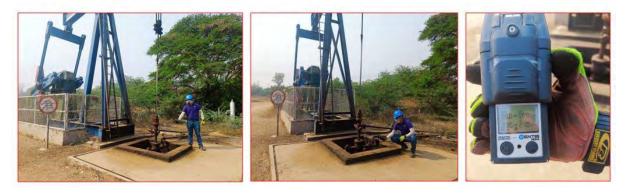
Figure 54: H2S Monitoring Activities

M- 384 (Beside Public Main Road and near Mann Kyoe Barrack)

M-537 (Beside Public Road)

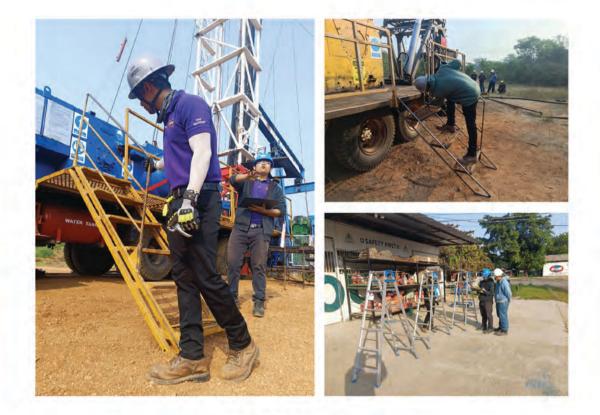
Figure 56: Ladders Inspection

As per the Field HSE plan, the HSE team conducted a Tri-annual Inspection for all portable ladders, emergency ladders at GOCSs, platform ladders at the pulling units, well site tanks ladders, and moveable ladders at the mechanical workshop & downhole workshop.

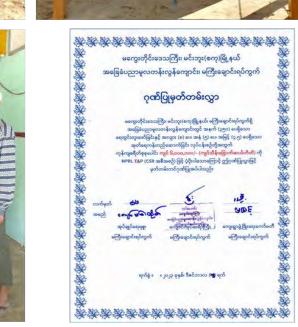
Figure 77: Drilling Water Well Drilling and Constructing Water Collection Tank at Makyee Chaung School

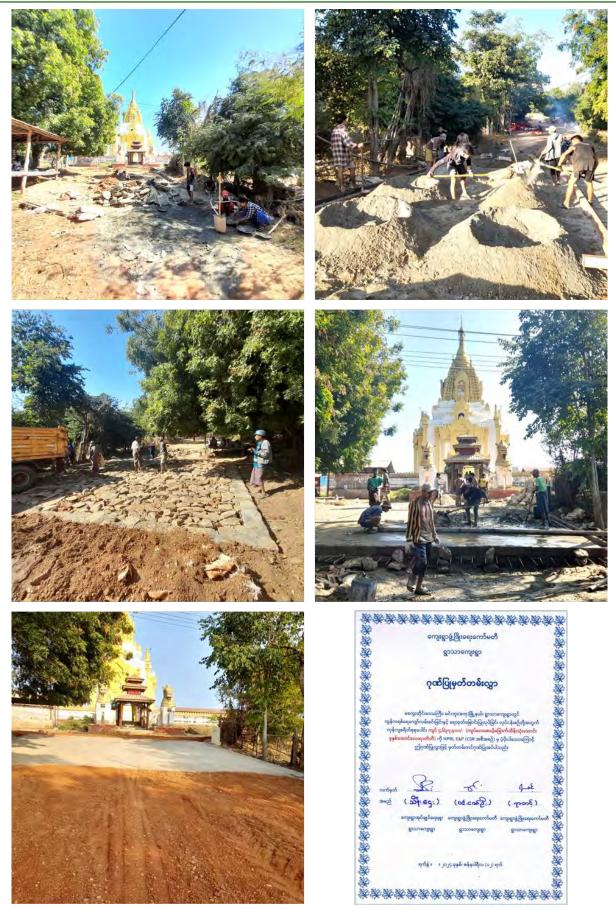
Figure 78: Constructing Road Concrete Slab and Drainage at Ywar Thar Village

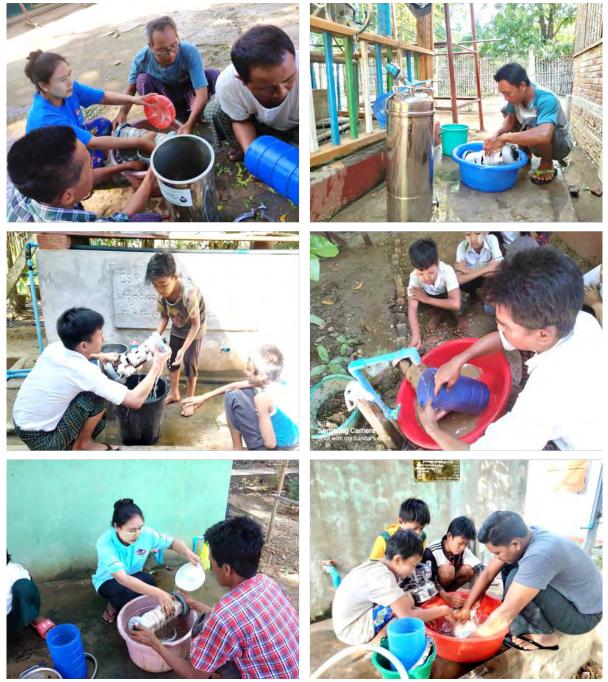
Figure 84: Monitoring Maintenance of Water Filtration Units at Schools in Mann Field
